9738

Australind Jetty

# **Australind Jetty Inspection Findings**

# **JETTY INSPECTION & REPORT**

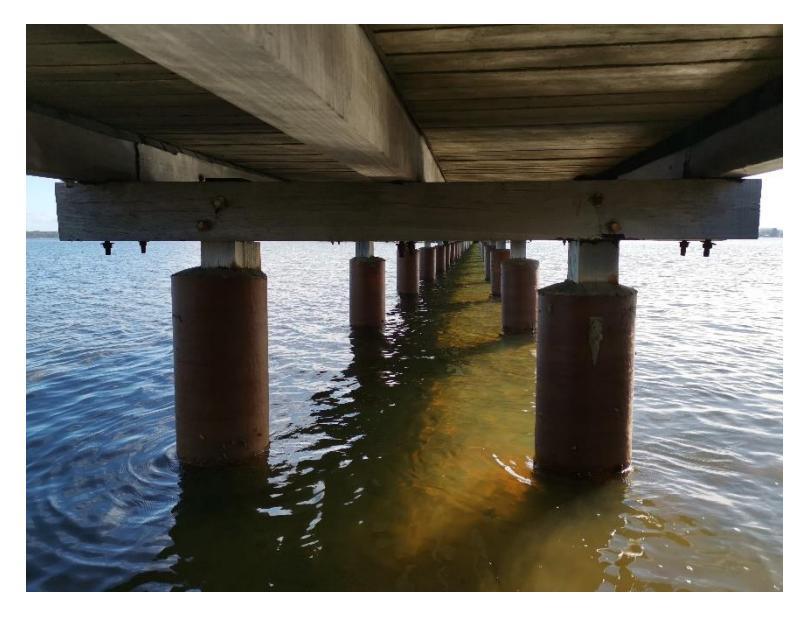
Figure 3. Piles

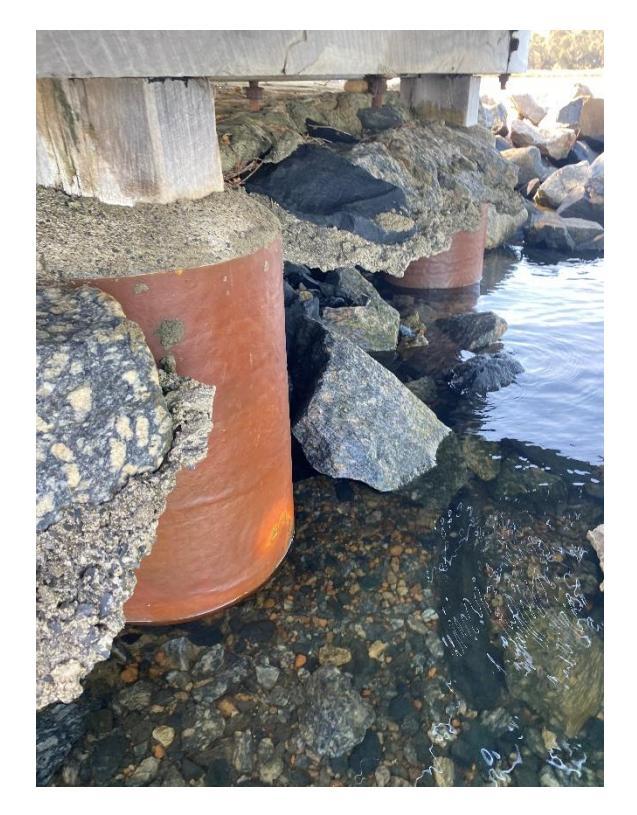
Figure 4. Piles and Corroded Bolts

All bolts should be replaced. We recommend that all the new bolts be stainless steel. Otherwise, galvanised bolts are acceptable, subject to a regular inspection regime.

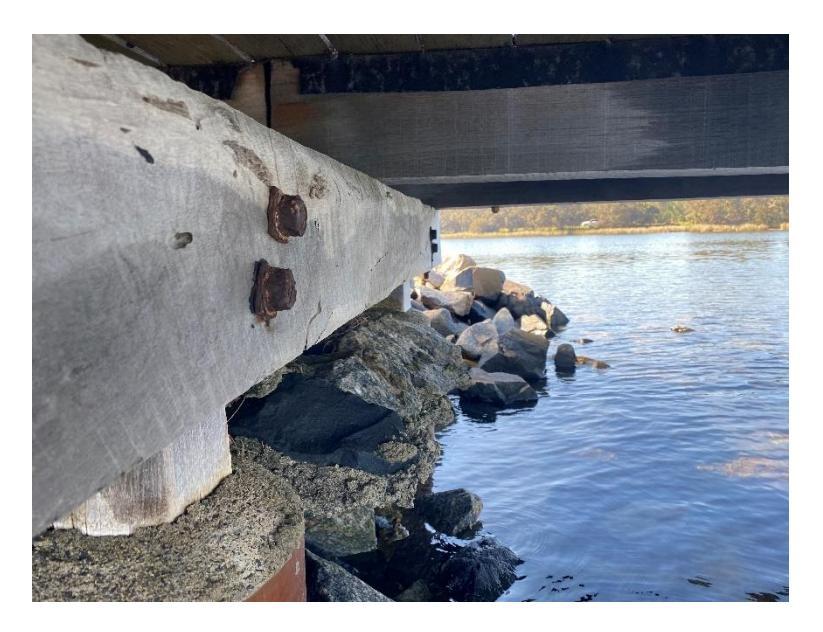
All the bolts observed are rusted. The timber stumps appear to be a bit weathered, but are not affecting the structural performance. Concrete piles seem to be in a good condition because of the wrapping encasing the piles (Figure 5).

Figure 5. Encapsulated Piles

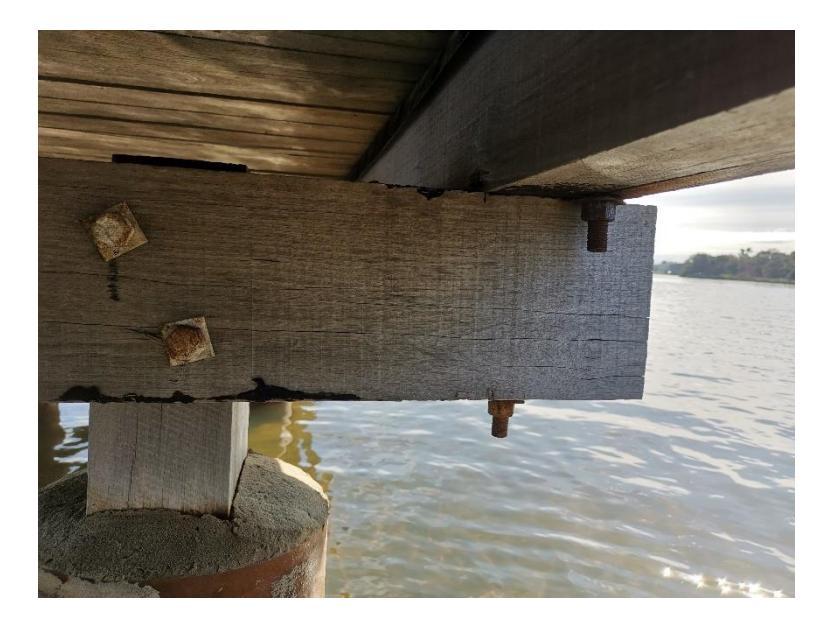
Figure 6. Corroded Bolts

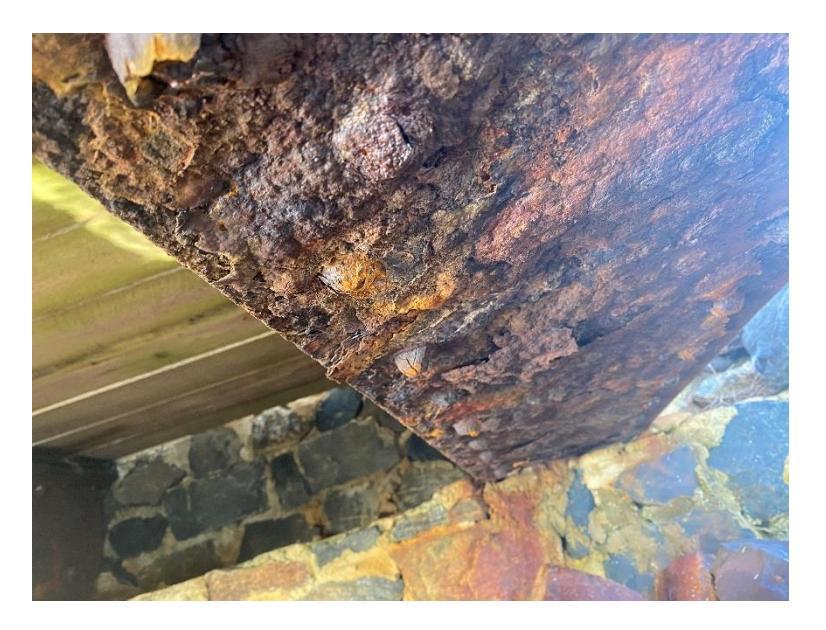
Most of the steelwork is showing signs of corrosion. All the bolts and the steel beams observed are rusted and, in several areas, delaminated (Figure 10, Figure 11, Figure 12, Figure 14).

Figure 10. Rusted and Delaminated Steel Beam

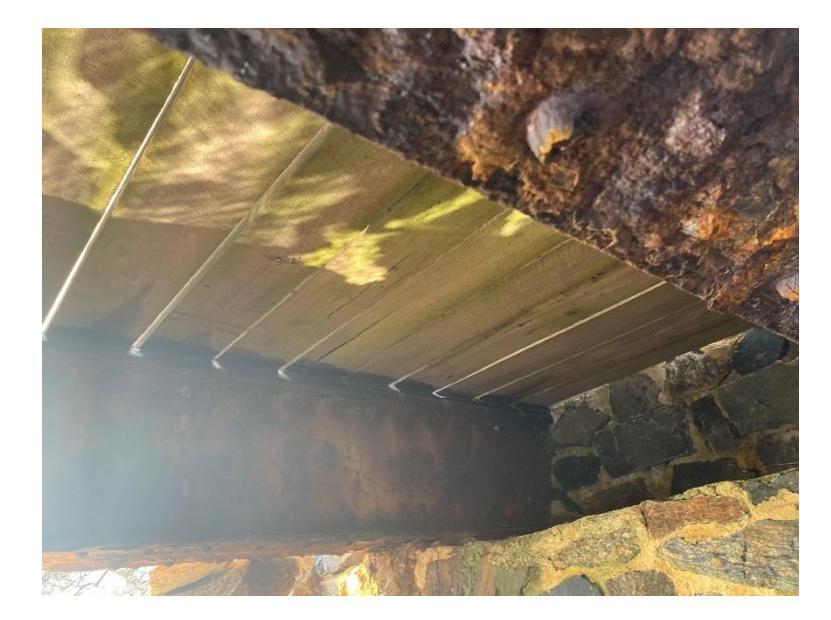
Figure 11. Delaminated and Rusted Steel Beam

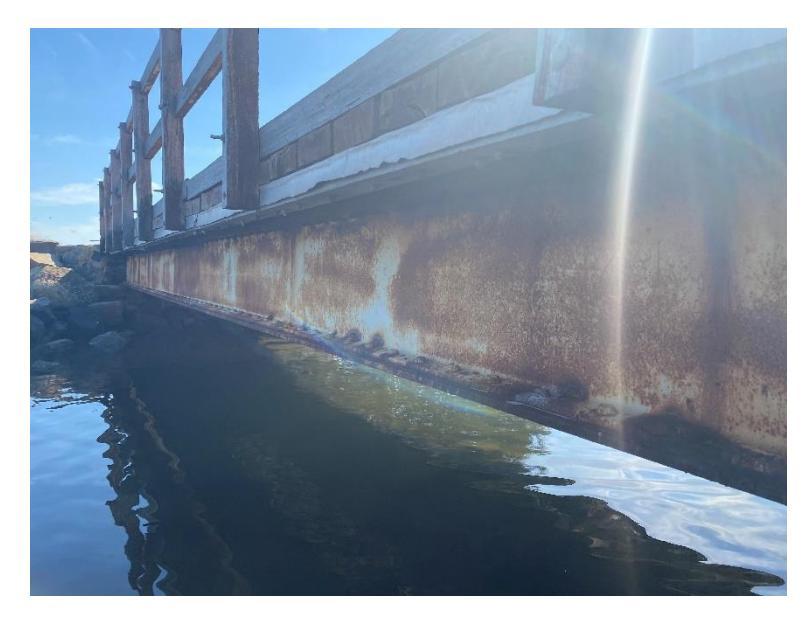
Figure 12. Corroded Steel Beam

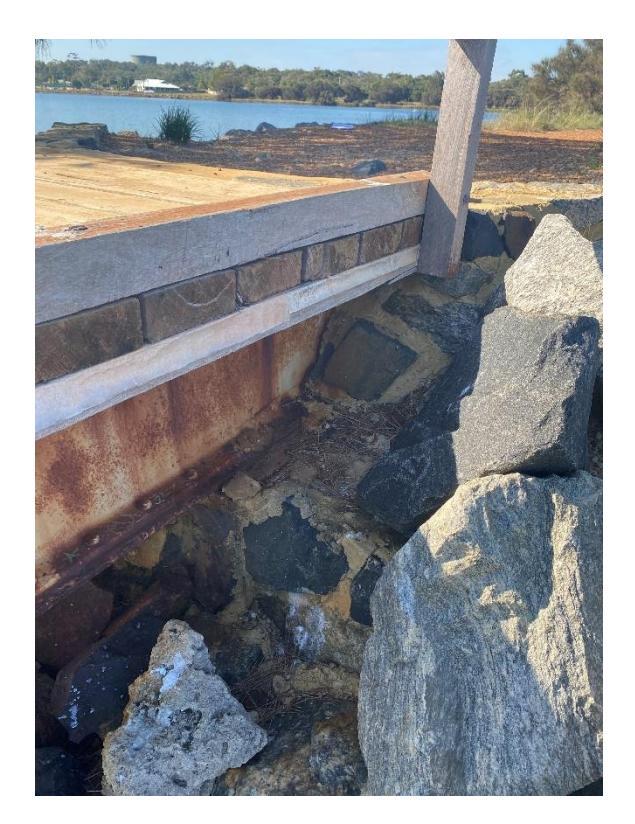
Figure 13. Abutment

Whilst the abutment is sound, there has been some erosion behind it. We recommend providing a new surface for an extent beyond the abutment to protect the ground from erosion.

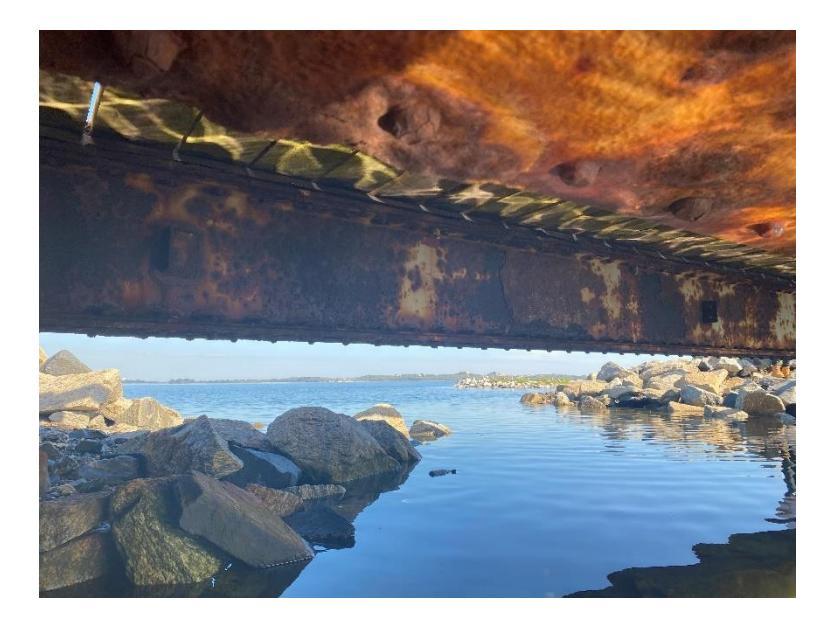
Figure 14. Rusted and Delaminated Steel Beam

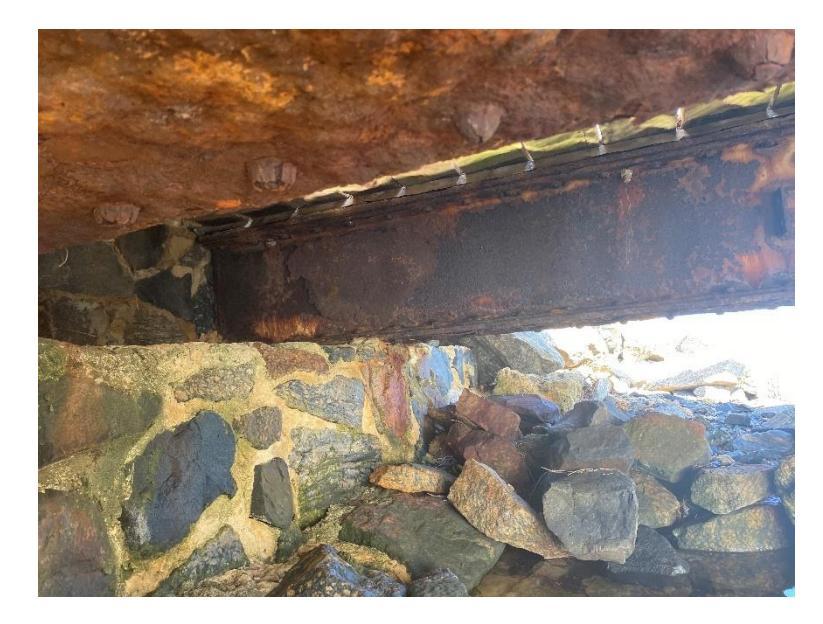
Figure 15. Abutment and Rusted Steel Beam

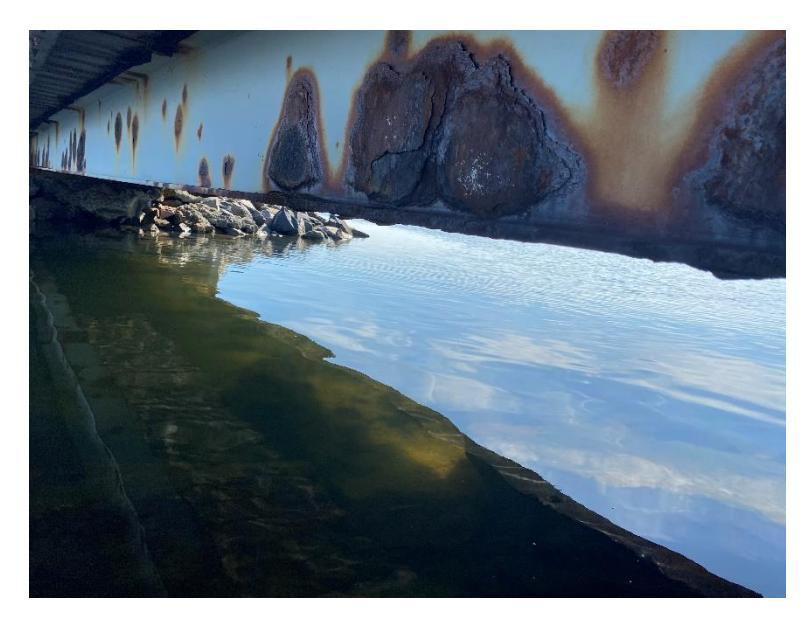
Most of the steelwork is showing signs of corrosion. All the bolts and the steel beams observed are rusted and, in several areas, delaminated (Figure 16, Figure 17, Figure 18).

Figure 16. Corroded Steel Beam

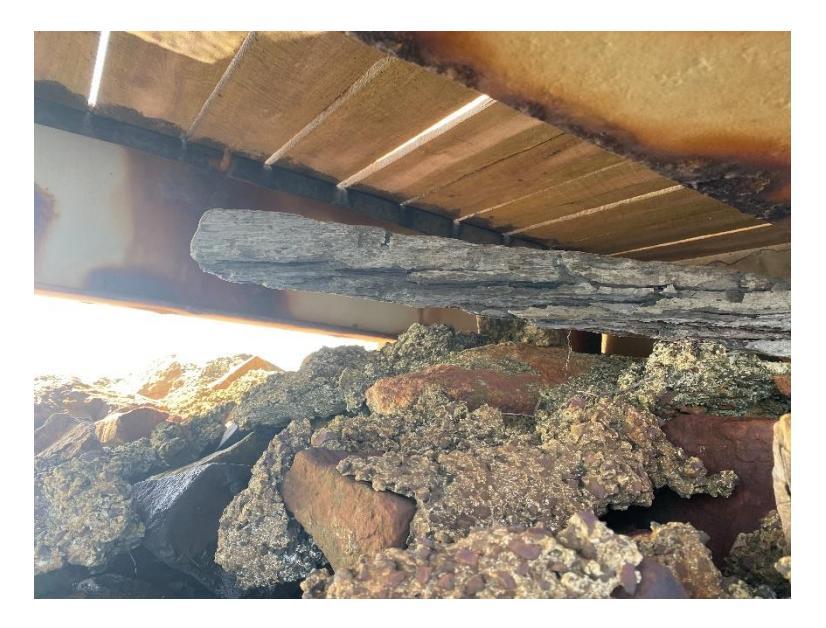
Figure 17. Steel Beam Underside

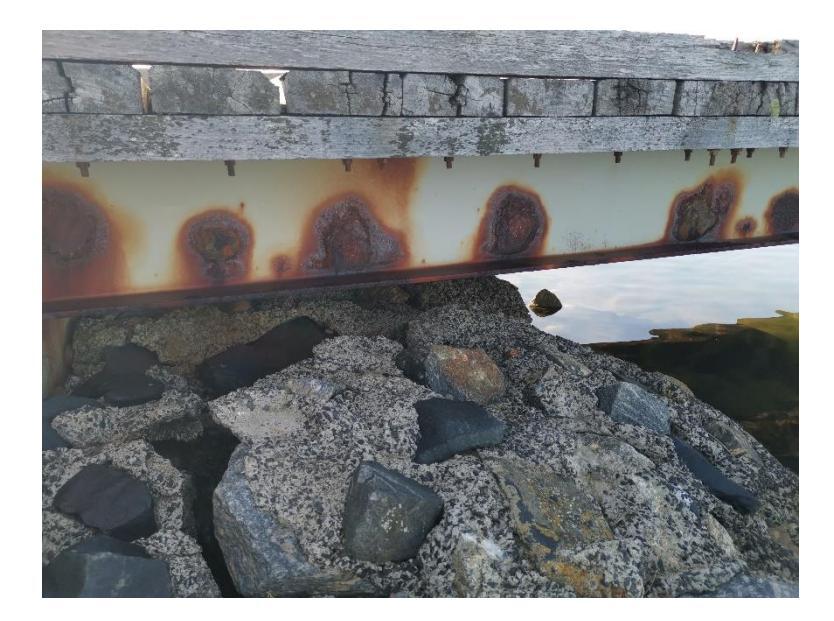
Figure 20. Abutment and Corroded Steel Beam

Whilst the abutment is sound, there has been some erosion behind it. We recommend providing a new surface for an extent beyond the abutment to protect the ground from erosion.

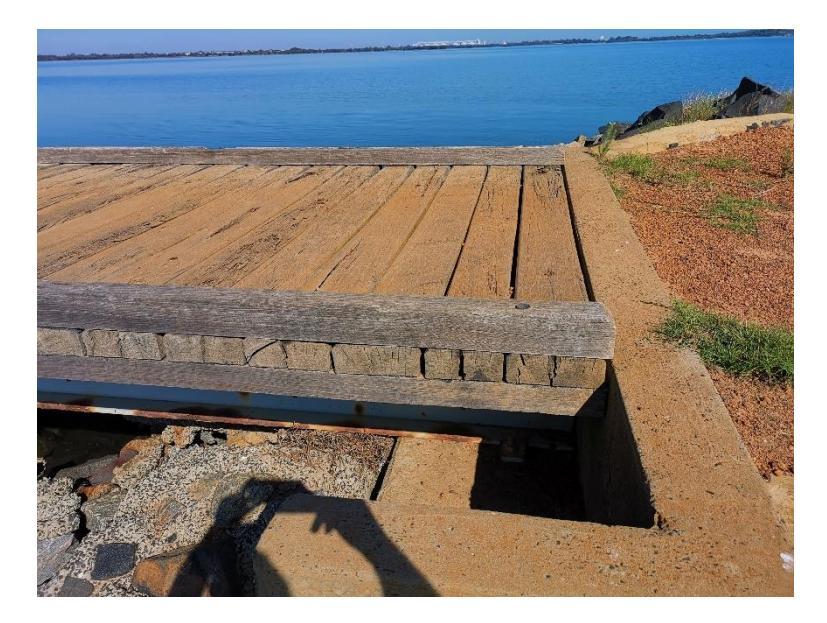
Figure 21. Weathered Deck Board

Due to the extent of deterioration to the deck boards. We recommend that they all be replaced. It would be prudent, with the boards removed, to inspect and replace the protective barrier over the joists.

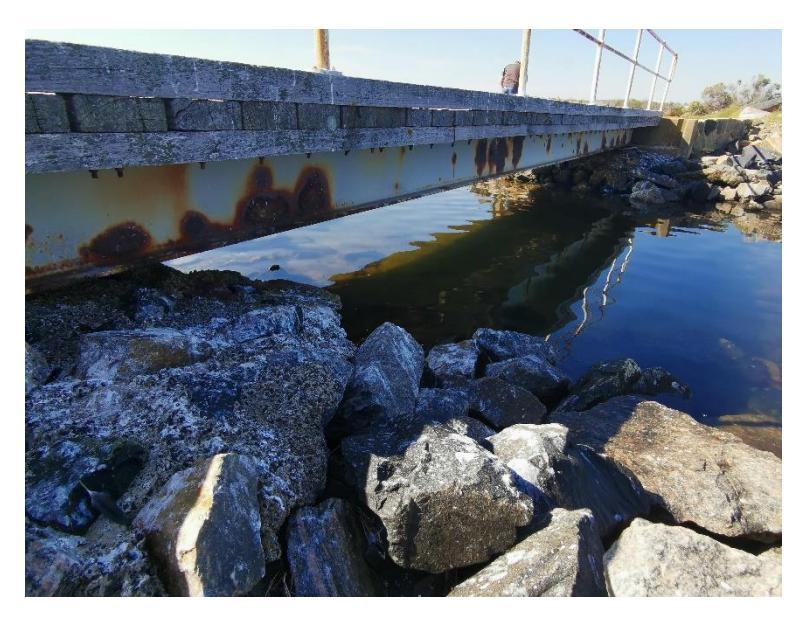
Most of the steelwork is showing signs of corrosion. All the bolts and the steel beams observed are rusted and, in several areas, delaminated (Figure 22, Figure 24, Figure 25, Figure 27).

Figure 22. Corroded Steel Beam

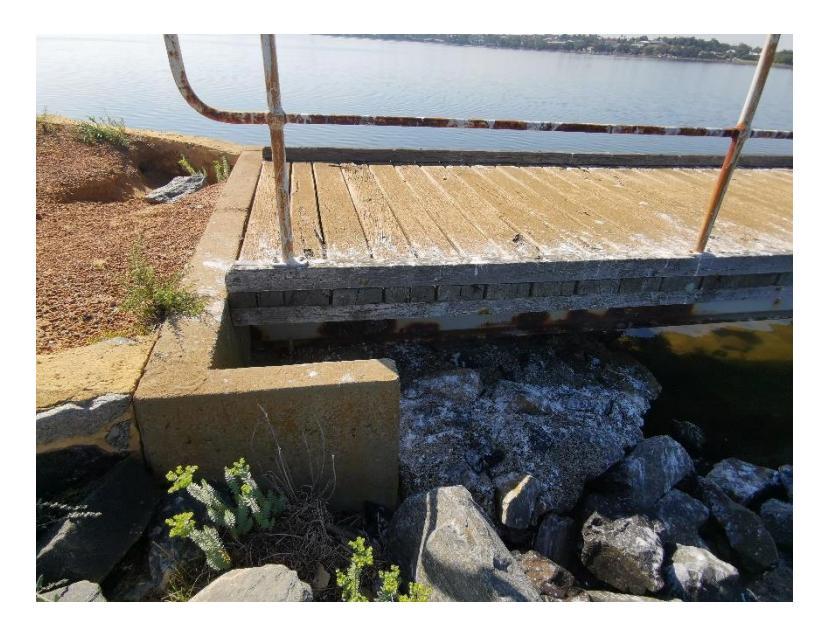
Generally, all the deck boards appear to be okay if a bit weathered. Several deck boards have cupped or split and there is the occasional loose one (Figure 23). However, these are not considered to be affecting the structural performance. Steel fenders were found to be firmly fixed when leant upon.

Figure 23. Corroded Handrail, Weathered Deck Board and Abutment

Due to the extent of deterioration to the deck boards. We recommend that they all be replaced. It would be prudent, with the boards removed, to inspect and replace the protective barrier over the joists.

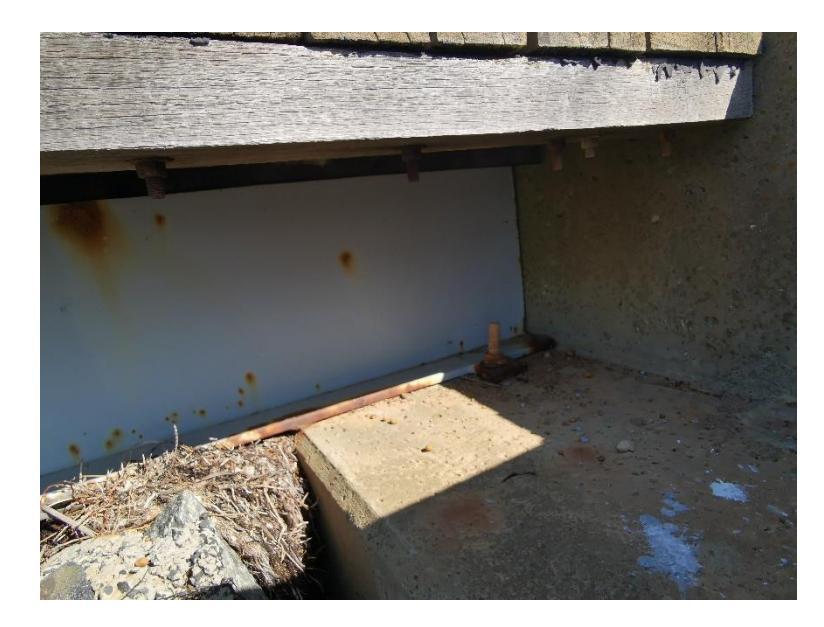
Figure 24. Rusted Bolt

All bolts should be replaced. We recommend that all the new bolts be stainless steel. Otherwise, galvanised bolts are acceptable, subject to a regular inspection regime.

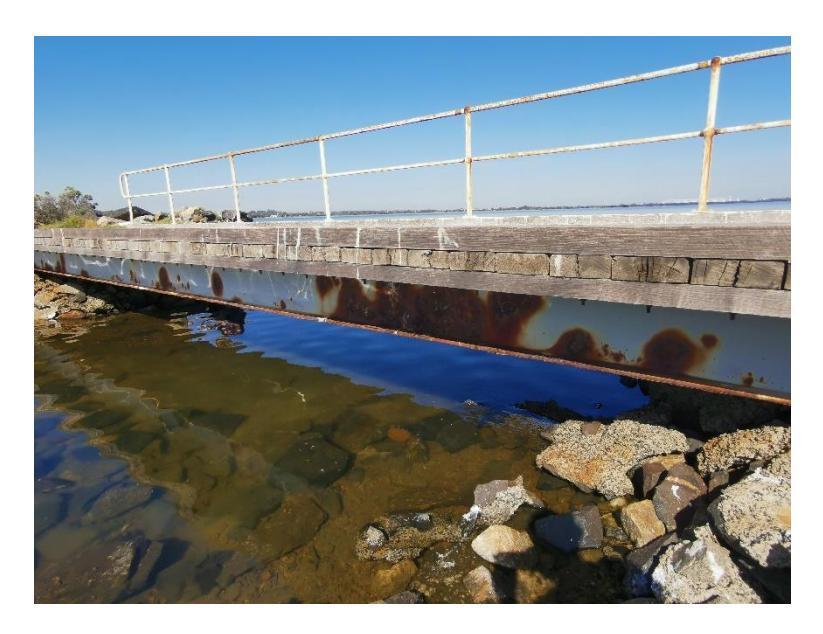
Figure 25. Delaminated and Rusted Steel Beam

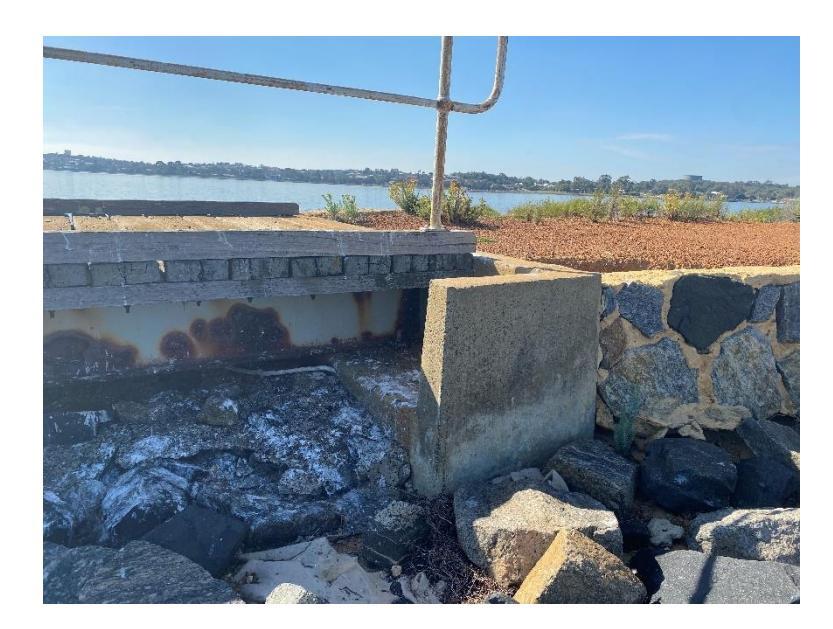
Figure 26. Rusted Steel Beam

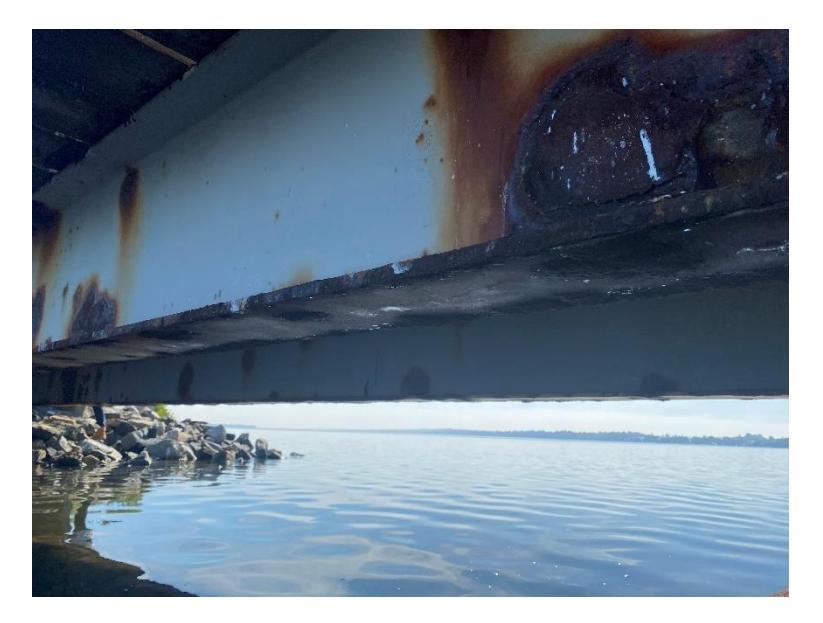
Figure 27. Delaminated Steel Beam

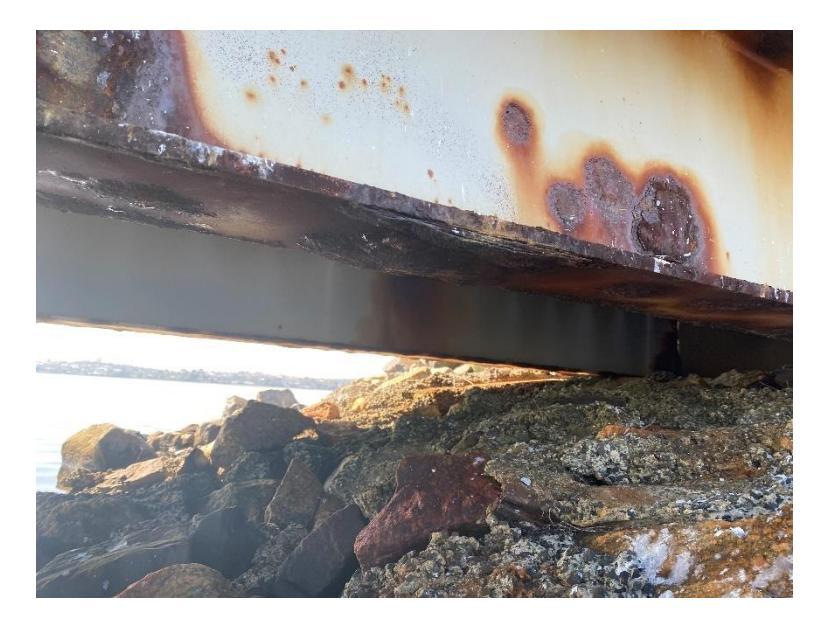
Figure 28. Rusted and Delaminated Steel Beam

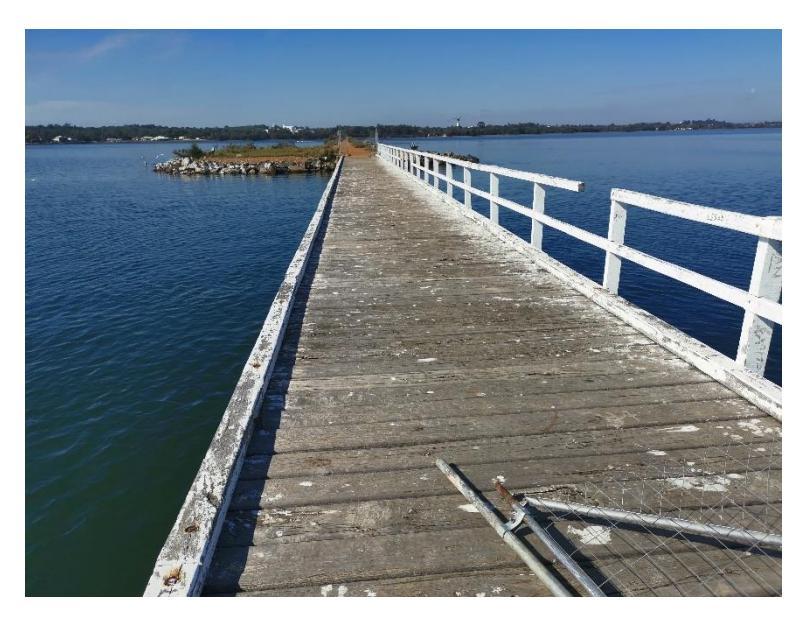
All the deck boards and toe boards appear to be weathered (Figure 29, Figure 31, Figure 33, Figure 35). Several deck boards have cupped or split and there is the occasional loose one. However, these are not considered to be affecting the structural performance of the jetty.

Figure 29. Weathered Deck Board and Broken Handrail

Due to the extent of deterioration to the deck boards. We recommend that they all be replaced. It would be prudent, with the boards removed, to inspect and replace the protective barrier over the joists.

We recommend the handrail arrangement is reviewed by yourselves, with regard to the extent and type of barrier, and the broken items replaced.

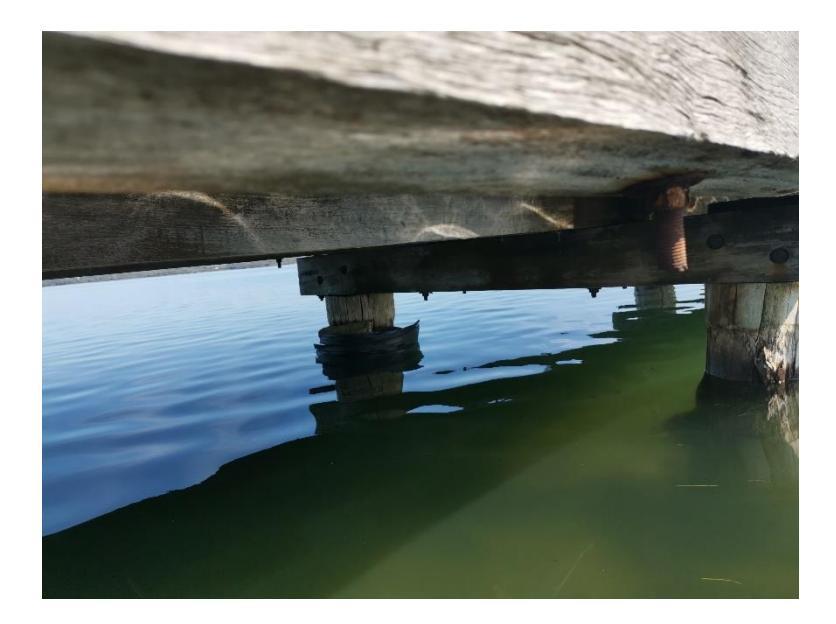
A few timber blocks between the piles and fenders have either split or weathered (Figure 30). Concrete encapsulations were found to be damaged (Figure 30). A more detailed report of underwater structure is attached in Appendix G.

Figure 30. Damaged Encapsulation in Piles

The diver's report has identified that pile encapsulations are in very poor condition. It is therefore recommended that these piles are either be repaired or replaced.

It is the diver's recommendation that all the existing encapsulations will need to be removed entirely, from the top of the column down to minimum of 500mm below the seabed. For a detailed recommendation, refer to diver's report in Appendix G.

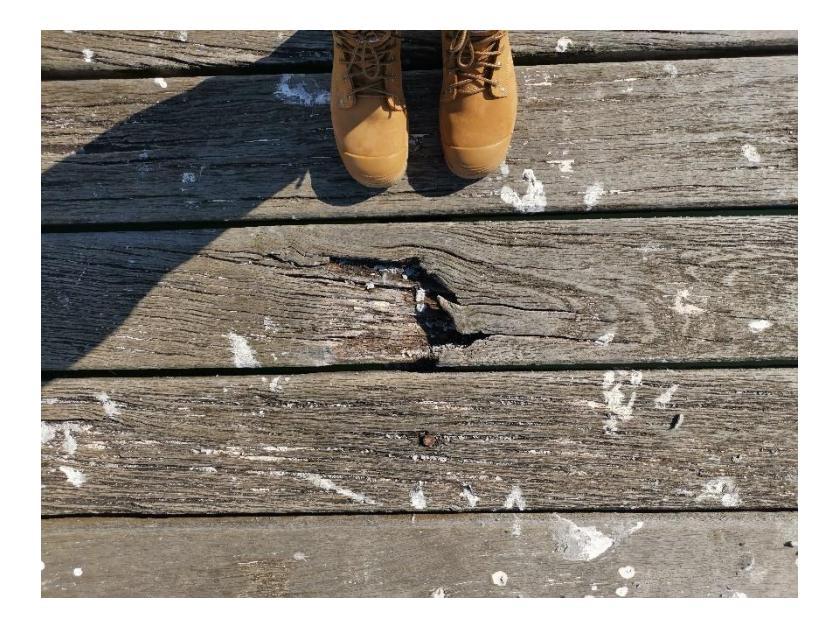
Figure 31. Damaged Deck Board

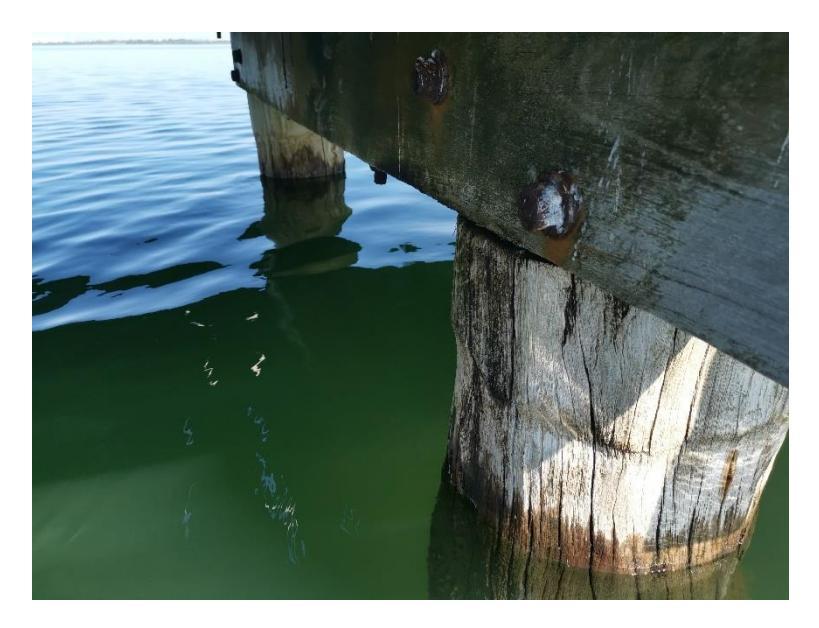
Figure 32. Cracks in Timber Piles, Rusted Bolts

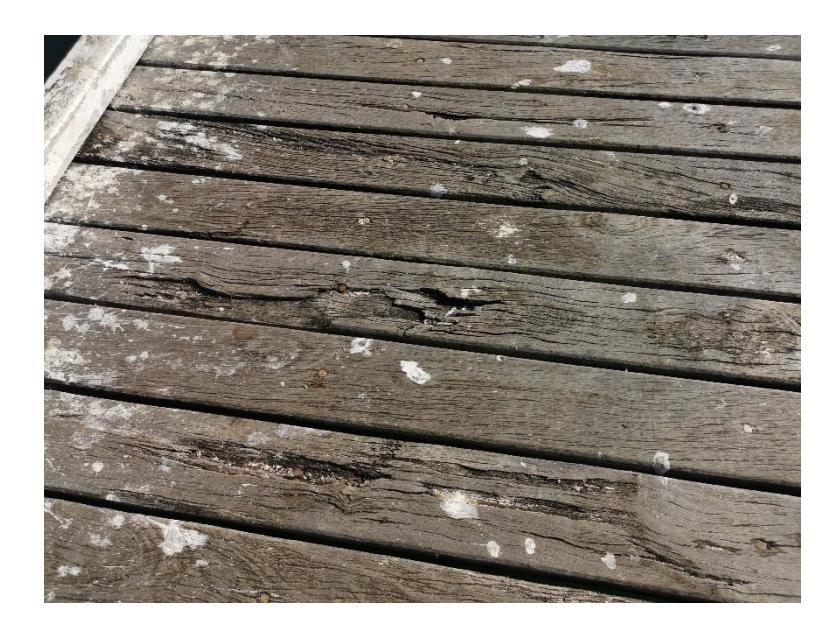
Figure 33. Soft, weathered and Broken Deck Board

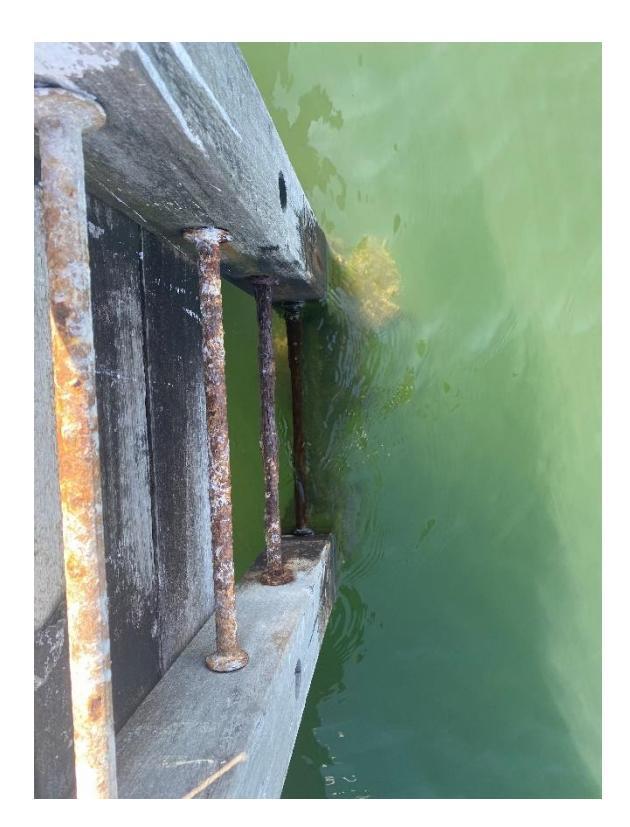
Figure 34. Rusted Ladder

The ladder on the structure has timber styles with steel bars running between to form the rungs. At the time of inspection, severe corrosion was present on the steel bars.

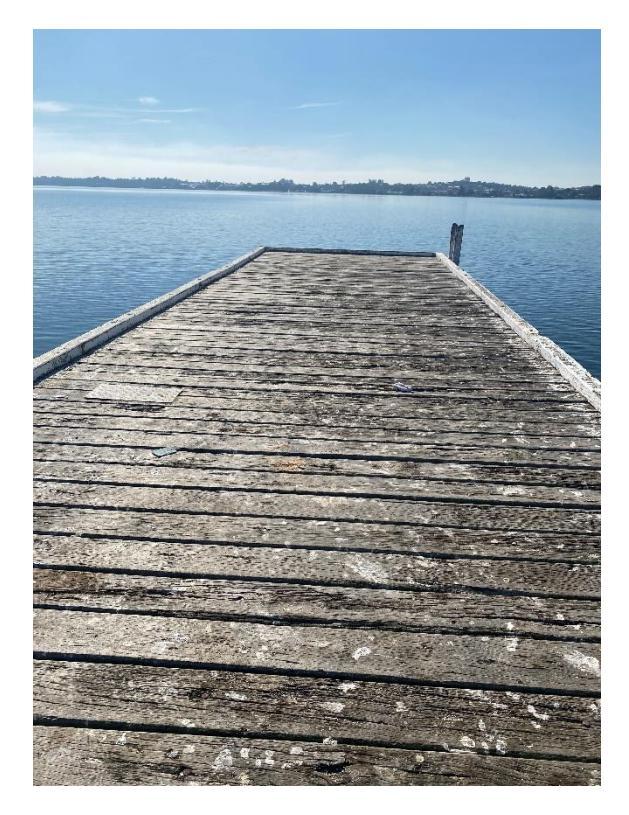
Figure 35. Weathered Deck Board

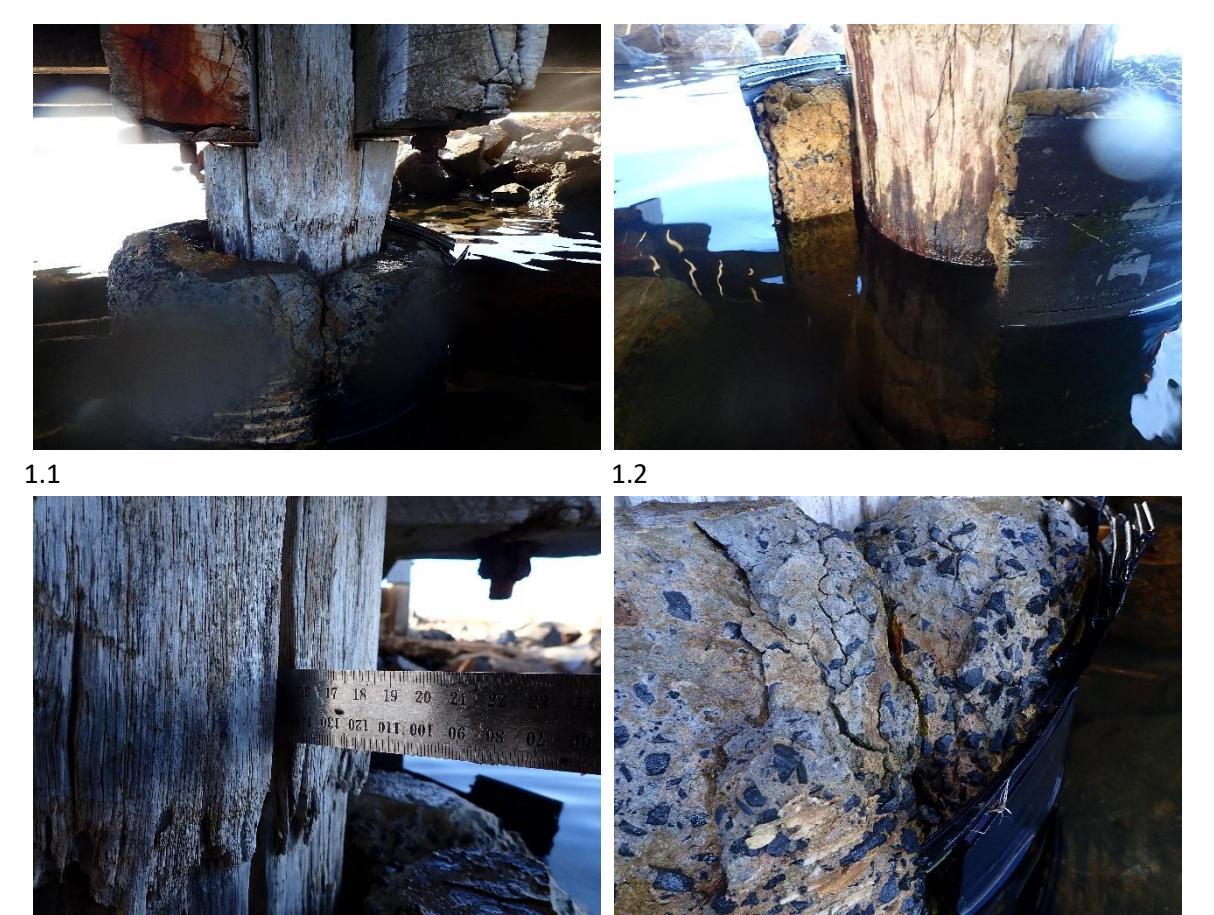
### 5.1 SITE PHOTOS PILE 1A

| Pier | Pile | I/T Circ | Seabed<br>Circ | Encapsulation<br>Circ | Probe<br>Test | Wood Rot | Splitting | Marine<br>Borer | Pile<br>length | Comments | Rating |
|---|---|---|---|---|---|---|---|---|---|---|---|
| 1 | A | 1080mm | NA | 1910mm | 2-4mm | Moderate<br>I/T | Severe I/T<br>160mm<br>deep on<br>exposed<br>timber | Minor I/T | 1030mm | Encapsulation extends below seabed. Severe section<br>loss to encapsulation 300mm x 400mm at top of pile<br>and severe cracking throughout. Plastic<br>wrap/formwork has completely failed around<br>encapsulation. | 4 |

- 1.1 Encapsulation failure with cracking and spalling
- 1.2 Encapsulation failure with severe section loss, no rebar present
- 1.3 Large split in pile (16mm)
- 1.4 Severe cracking and spalling on concrete encapsulation

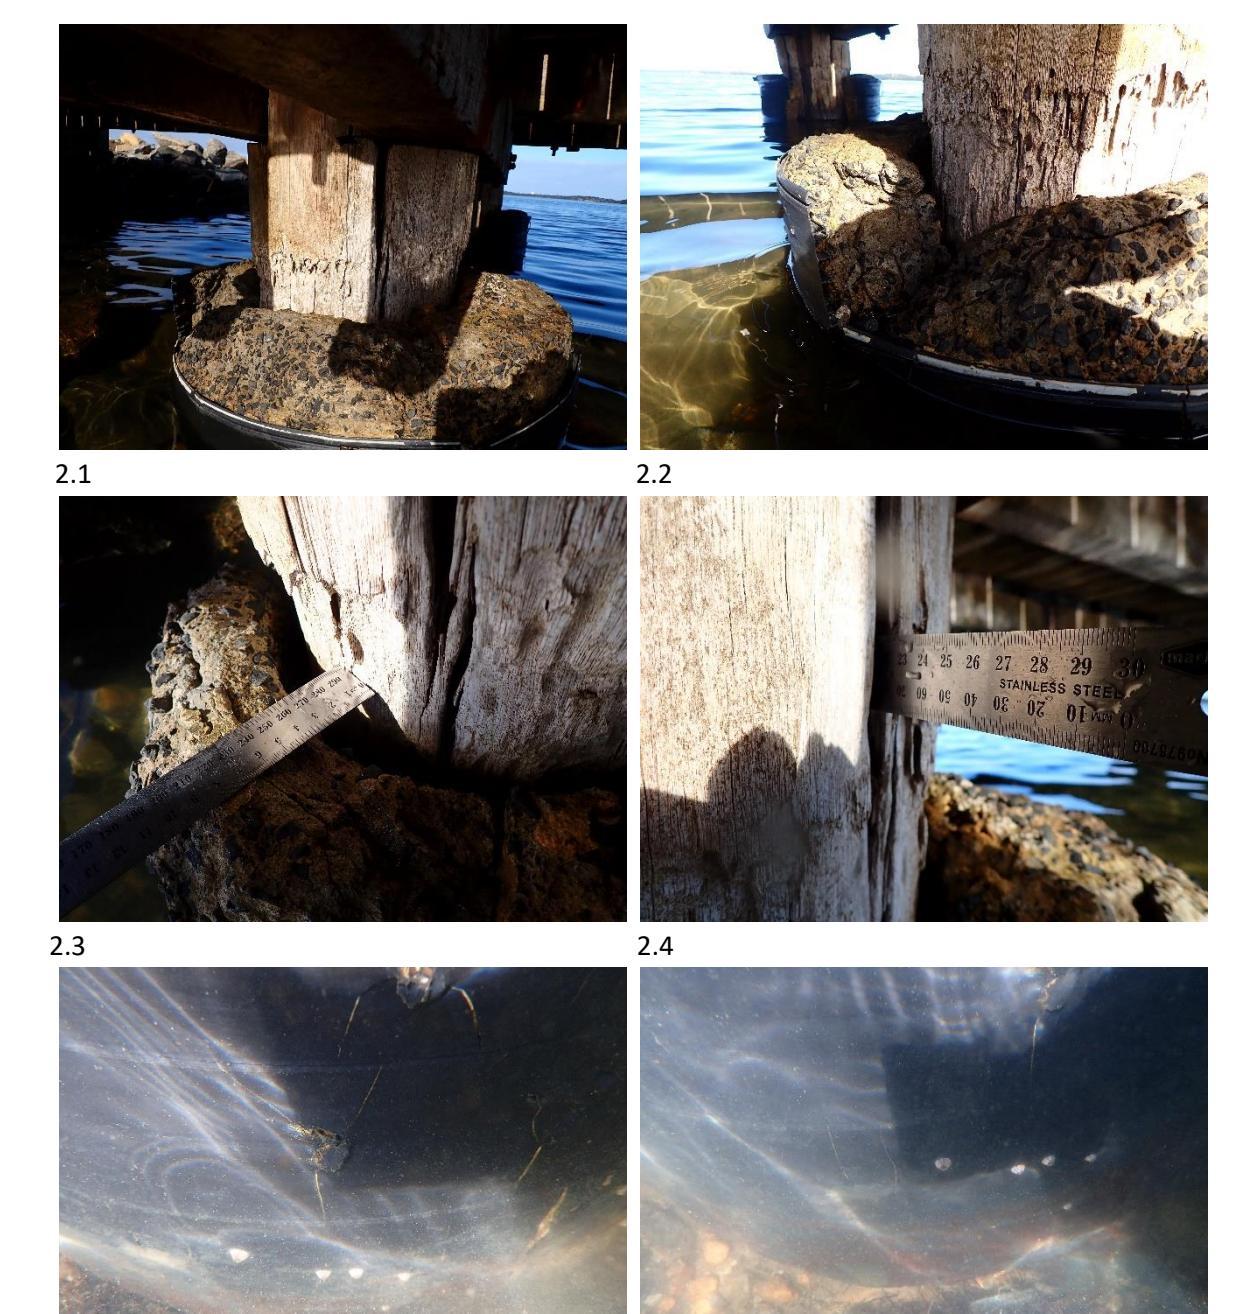
### 5.2 SITE PHOTOS PILE 1B

| Pier | Pile | I/T Circ | Seabed<br>Circ | Encapsulation<br>Circ | Probe<br>Test | Wood Rot | Splitting | Marine<br>Borer | Pile<br>length | Comments | Rating |
|---|---|---|---|---|---|---|---|---|---|---|---|
| | В | 1010mm | NA | 1940mm | 2-4mm | Moderate<br>I/T | Severe I/T<br>230mm<br>deep at<br>worst<br>point | Moderate<br>I/T | 840mm | Encapsulation extends below seabed. Encapsulation<br>has severe cracking/delamination to top 200mm.<br>Top 150mm of plastic wrap/ formwork has failed<br>completely. | 4 |

- 2.1 & 2.2 Encapsulation has severe cracking/and section loss to top 200mm.
- 2.3 Typical example of gap between pile concrete column and timber pile
- 2.4 Large split in pile
- 2.5 Damage to encapsulation formwork near seabed
- 2.6 Damage to encapsulation formwork near seabed

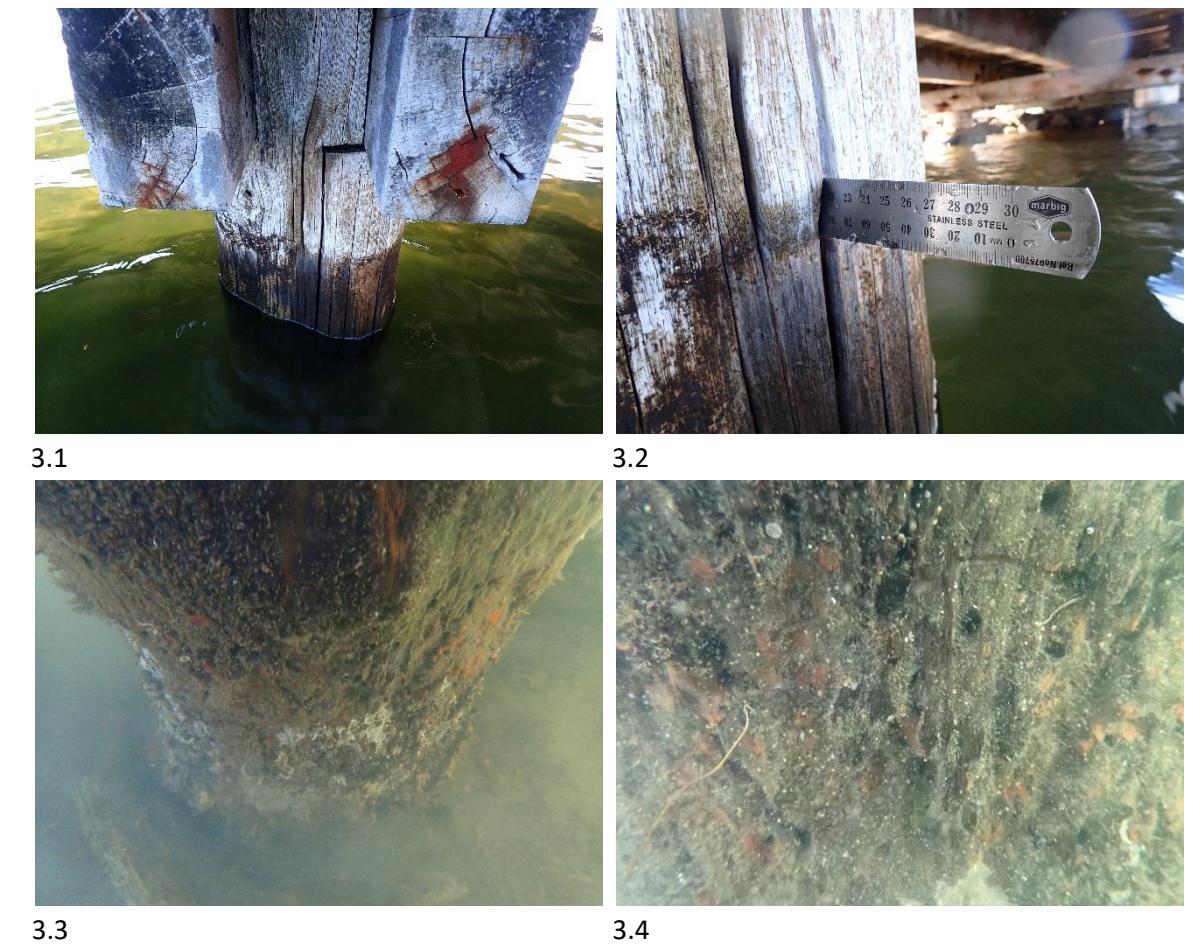
5.3 SITE PHOTOS PILE 2A

| Pier | Pile | I/T Circ | Seabed<br>Circ | Encapsulation<br>Circ | Probe<br>Test | Wood Rot | Splitting | Marine<br>Borer | Pile<br>length | Comments | Rating |
|---|---|---|---|---|---|---|---|---|---|---|---|
| 2 | A | 1130mm | 1100mm | NA | 2-4mm | Minor I/T,<br>Severe at<br>Seabed | Moderate<br>I/T 220mm<br>deep at<br>worst<br>point | Minor I/T,<br>Severe at<br>Seabed | 1220mm | Encapsulation has completely failed to seabed level.<br>Minor necking to timber at seabed. | 4 |

- 3.1 Encapsulation has completely failed to seabed level
- 3.2 Severe split in pile
- 3.3 & 3.4 Encapsulation has completely failed to seabed level, severe wood rot and marine borer attack

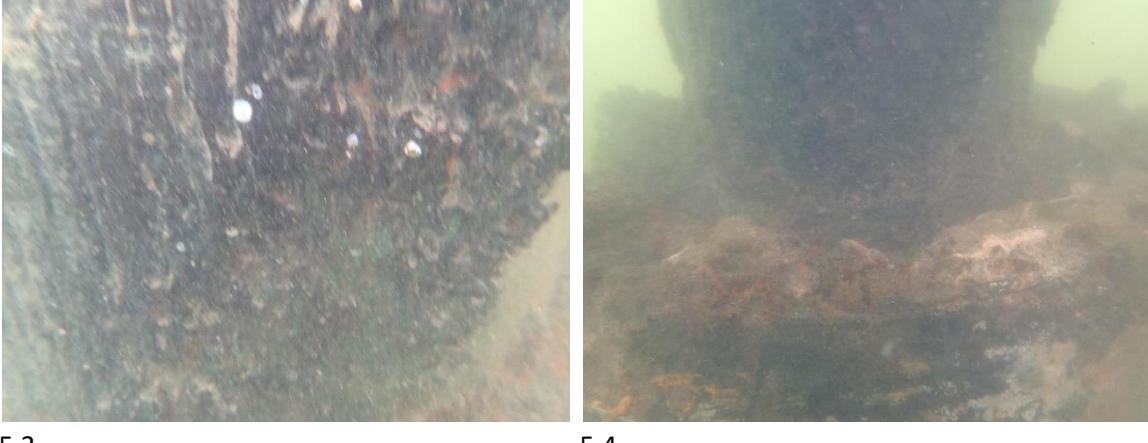
5.5 SITE PHOTOS PILE 3A

- 5.1 Encapsulation has failed on top 900mm
- 5.2 Large split in pile
- 5.3 Typical example of wood rot & borer, present on exposed sections of timber pile
- 5.4 Seabed encapsulation, with a significant section of the concrete column missing

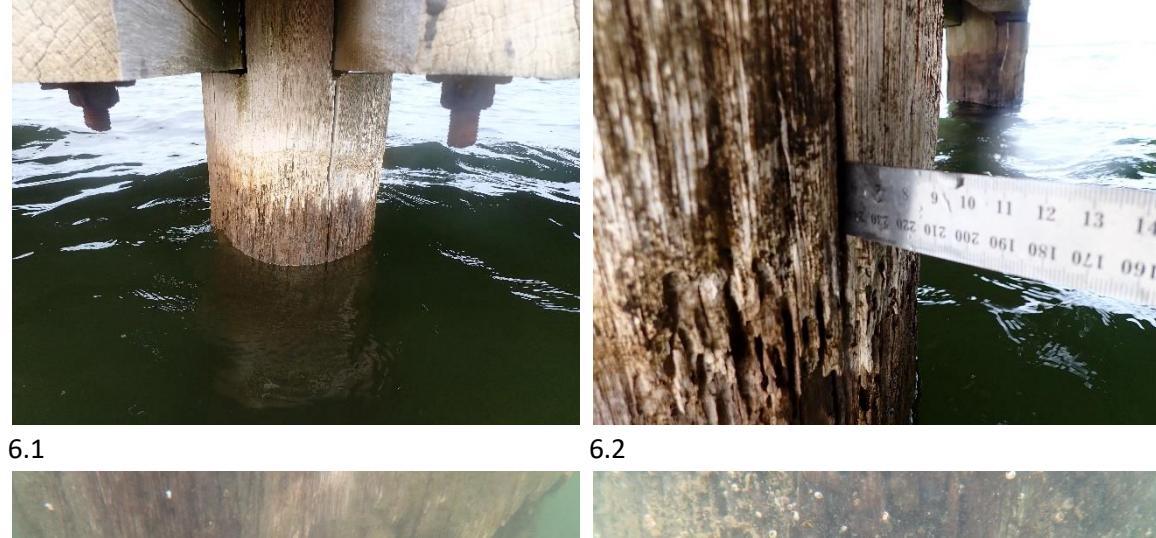
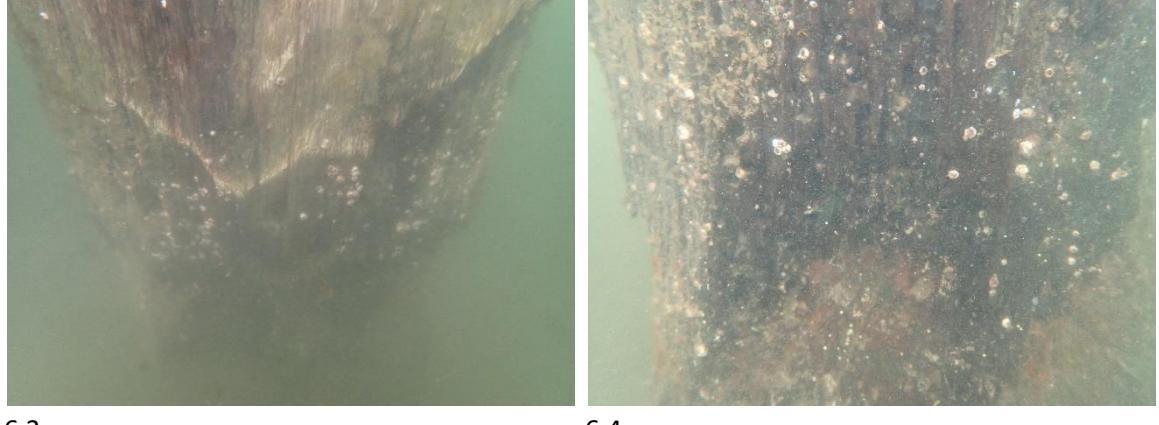
5.6 SITE PHOTOS PILE 3B

- 6.4
- 6.1 Encapsulation has completely failed to seabed level, top of pile presenting in good condition
- 6.2 Large split in pile
- 6.3 Moderate necking on subsea section of timber pile
- 6.4 severe wood rot & borer on subsea section of timber pile
