9738

Australind Jetty

# **Australind Jetty Inspection Findings**

# **JETTY INSPECTION & REPORT**

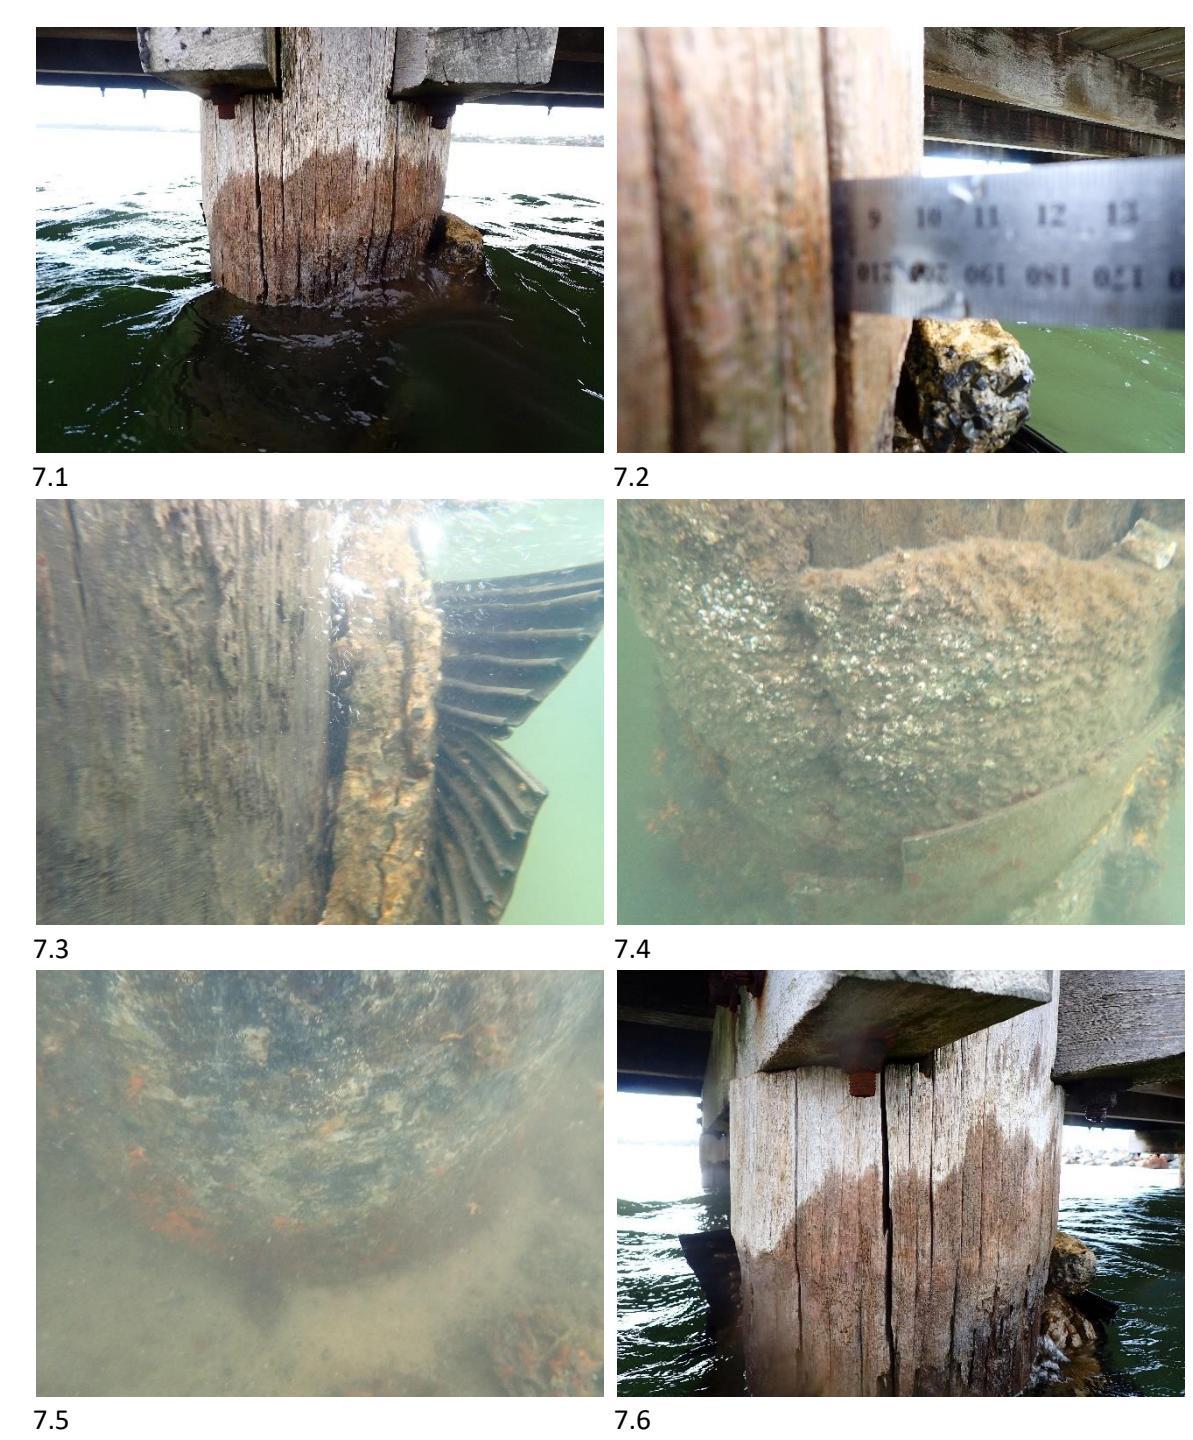
- 7.1 Encapsulation extends below seabed. Severe section loss to encapsulation at top 800mm of pile
- 7.2 Large split in pile
- 7.3 Severe section loss to encapsulation at top of pile 800mm x 500mm
- 7.4 Severe section loss to encapsulation at top of pile 800mm x 500mm
- 7.5 Seabed level encapsulation, presenting in fair condition
- 7.6 Large split in pile, large section loss to encapsulation

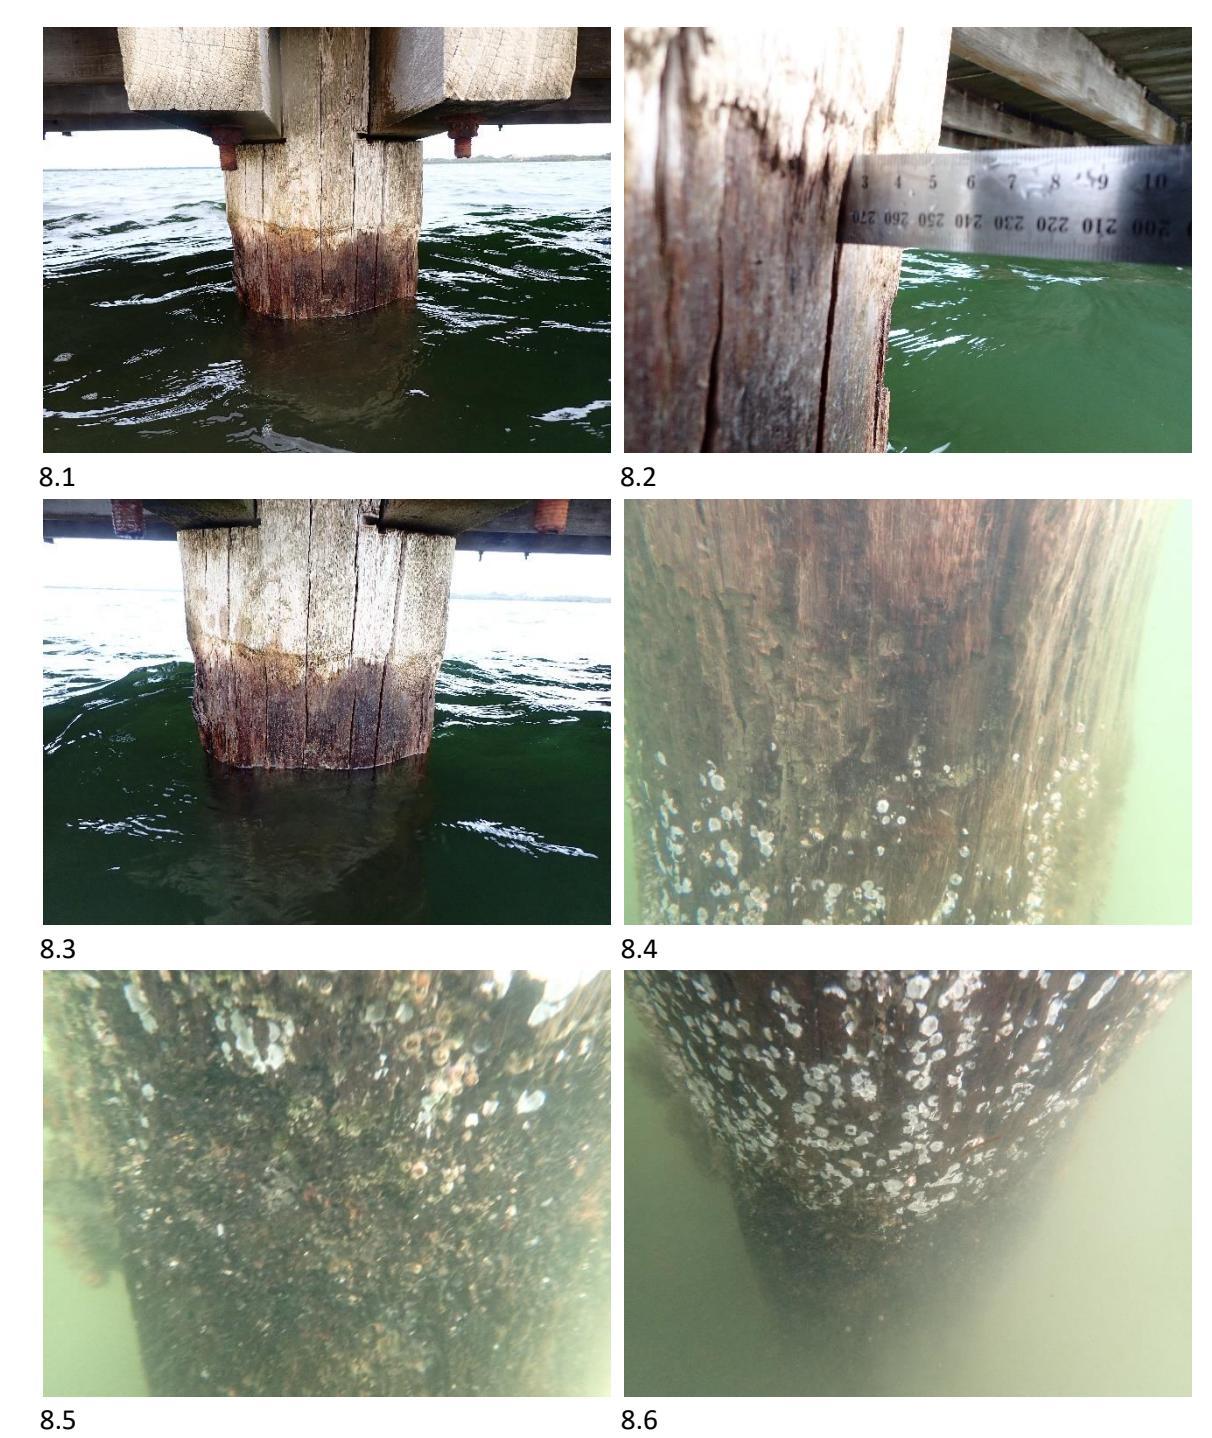
### 5.8 SITE PHOTOS PILE 4B

- 8.1 Encapsulation has completely failed to seabed level, top of pile presenting in good condition
- 8.2 Large split in pile
- 8.3 Moderate necking present at top of intertidal column
- 8.4, 8.5 & 8.6 Severe wood rot & borer present throughout subsea portion of timber pile

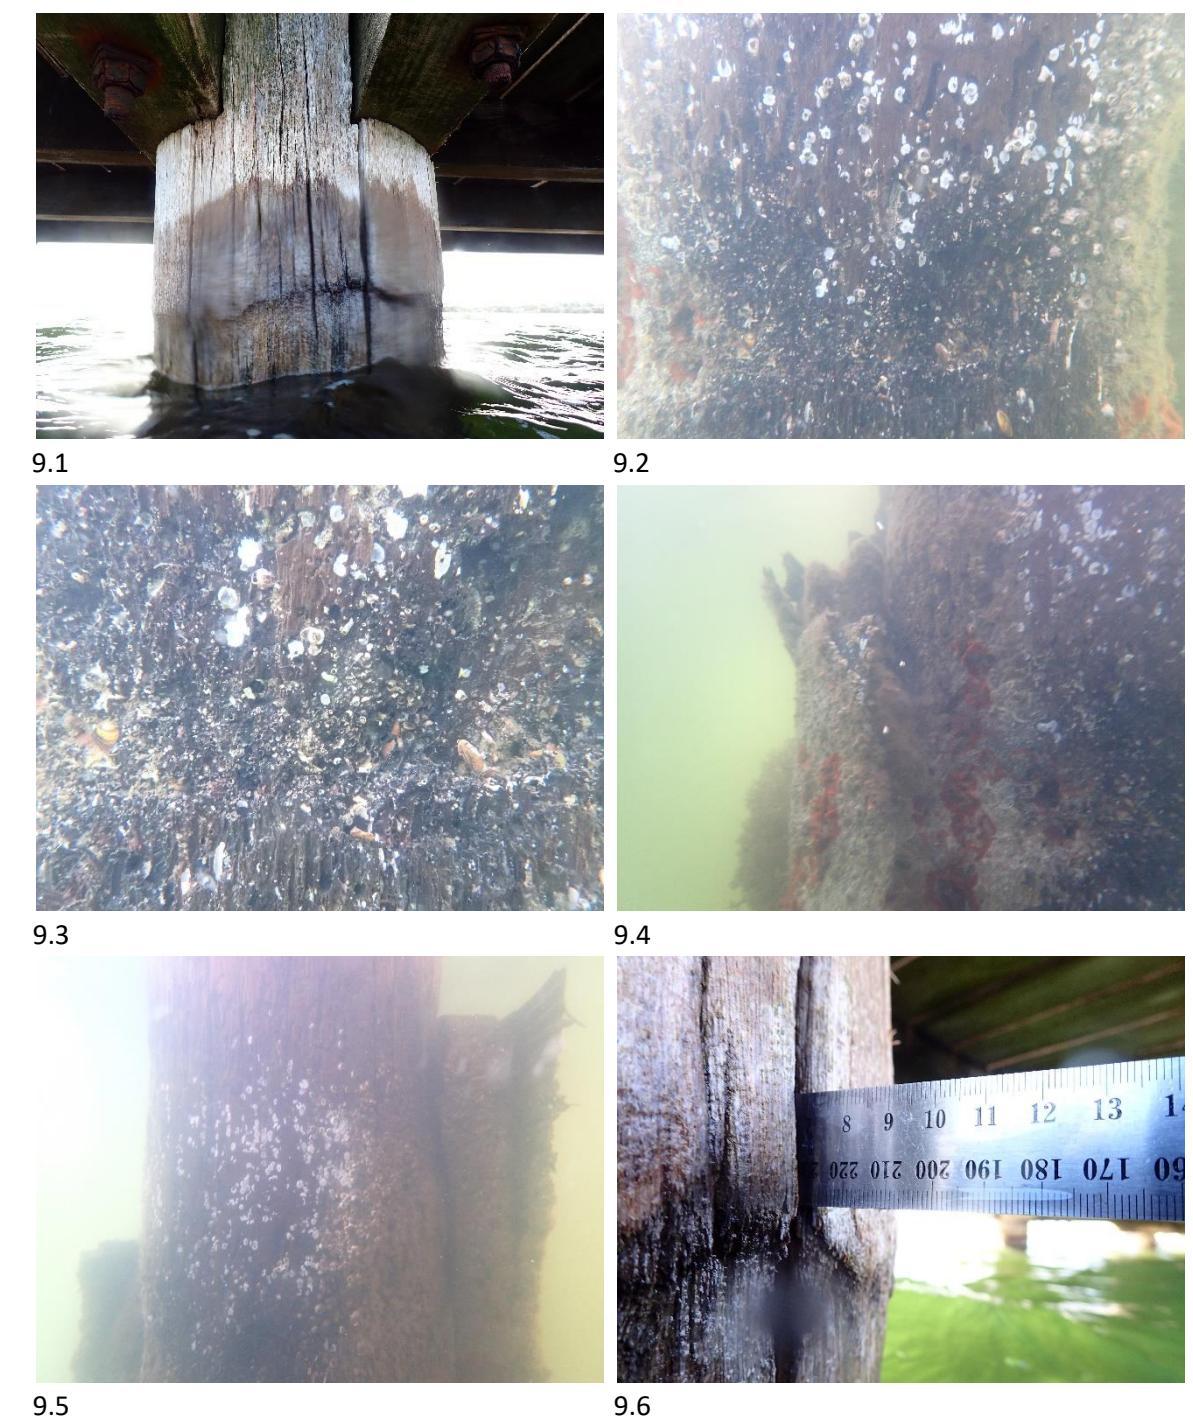
5.9 SITE PHOTOS PILE 5A

9.1 - Severe section loss at top of encapsulation 900mm wide extending down 1300mm, pile presenting with moderate splitting & necking on upper section

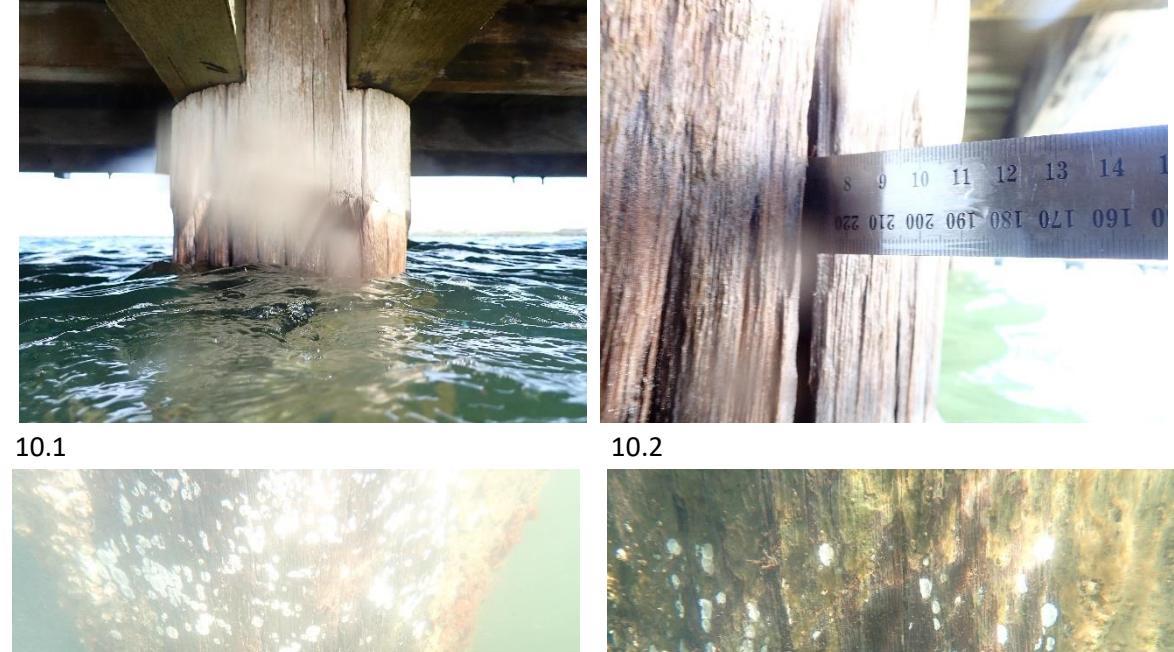
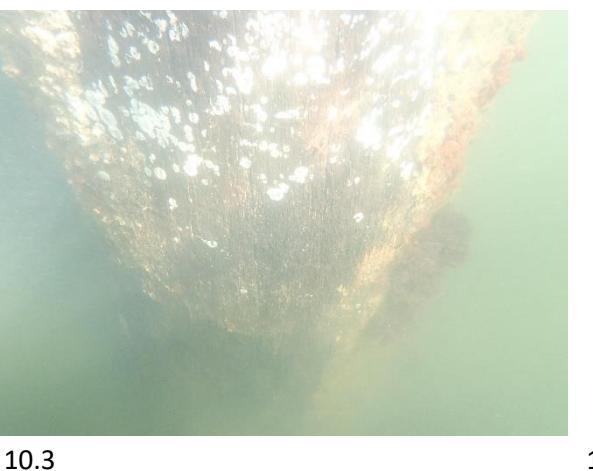
### 5.10 SITE PHOTOS PILE 5B

10.1 – Encapsulation is completely missing down to seabed level. Top above water section of pile presenting in good condition with minor-moderate splitting

10.3 & 13.4 – Typical example of minor wood rot

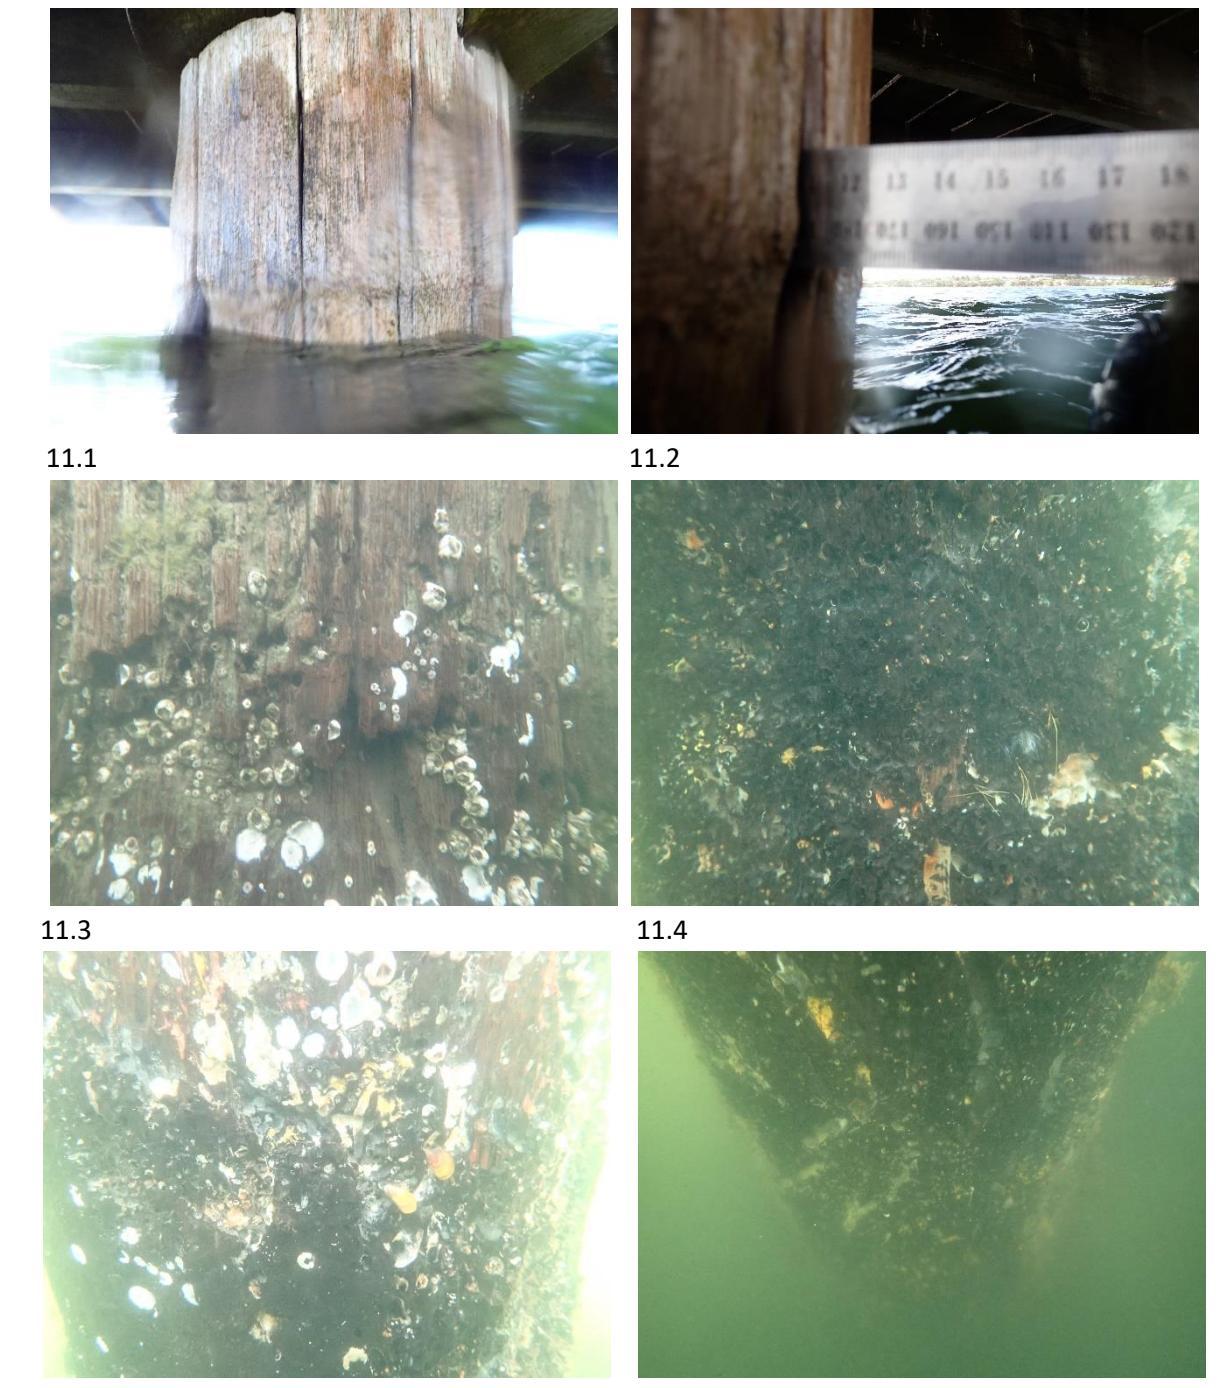
### 5.11 SITE PHOTOS PILE 6A

- 11.1 Encapsulation is completely missing down to seabed level. Top above water section of pile presenting in good
- 11.2 Example of moderate split in above water section of pile
- 11.3 Example of timber rot and borer attack on exposed section of subsea timber pile
- 11.4 ,11.5 & 11.6- Pile encapsulation formwork, presenting in fair condition

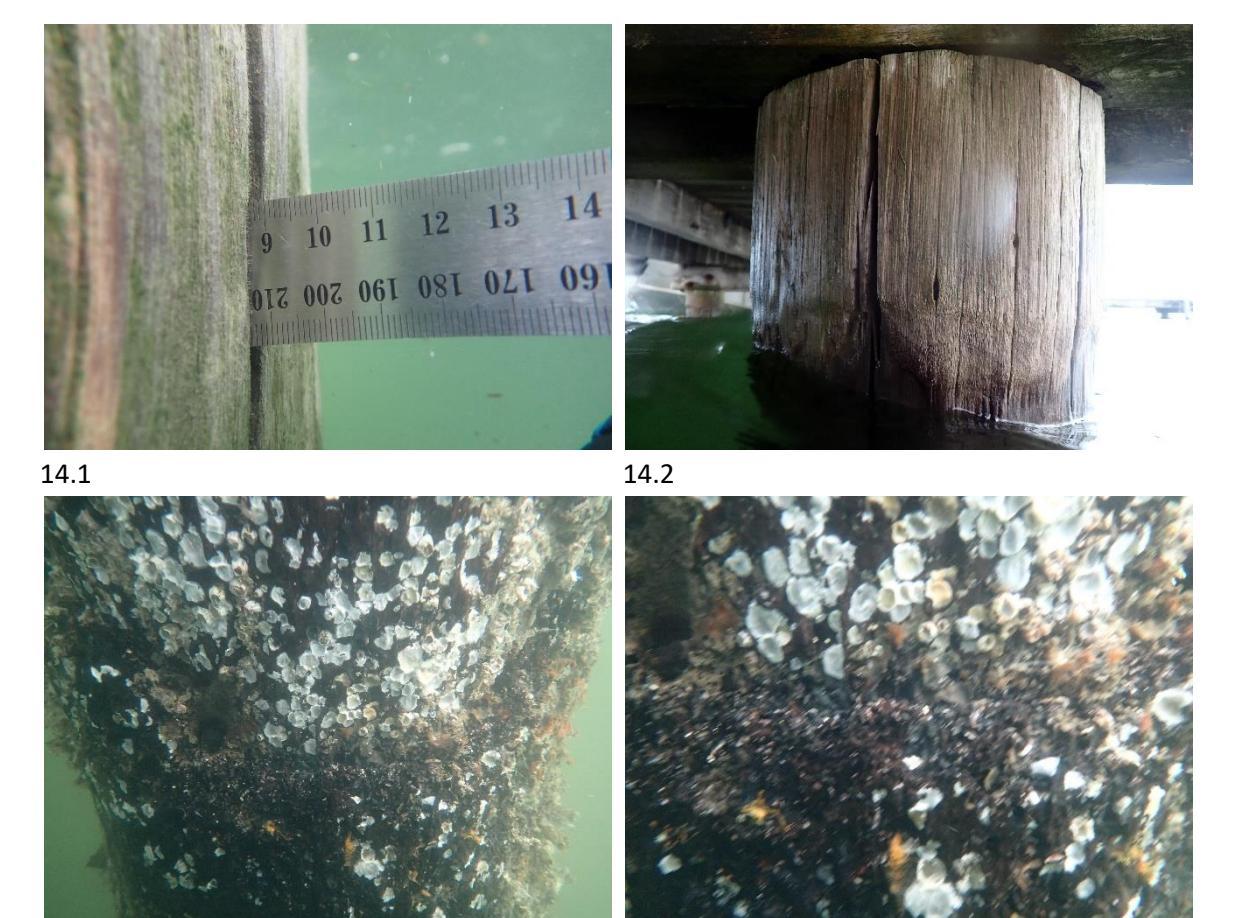
### 5.14 SITE PHOTOS PILE 7B

- 14.1 Example of moderate split in pile
- 14.2 Above water section of pile presenting in fair condition, with minor-moderate splitting
- 14.3 & 14.4 large section loss of encapsulation below LAT. Underlying timber presenting with minor-moderate rot.

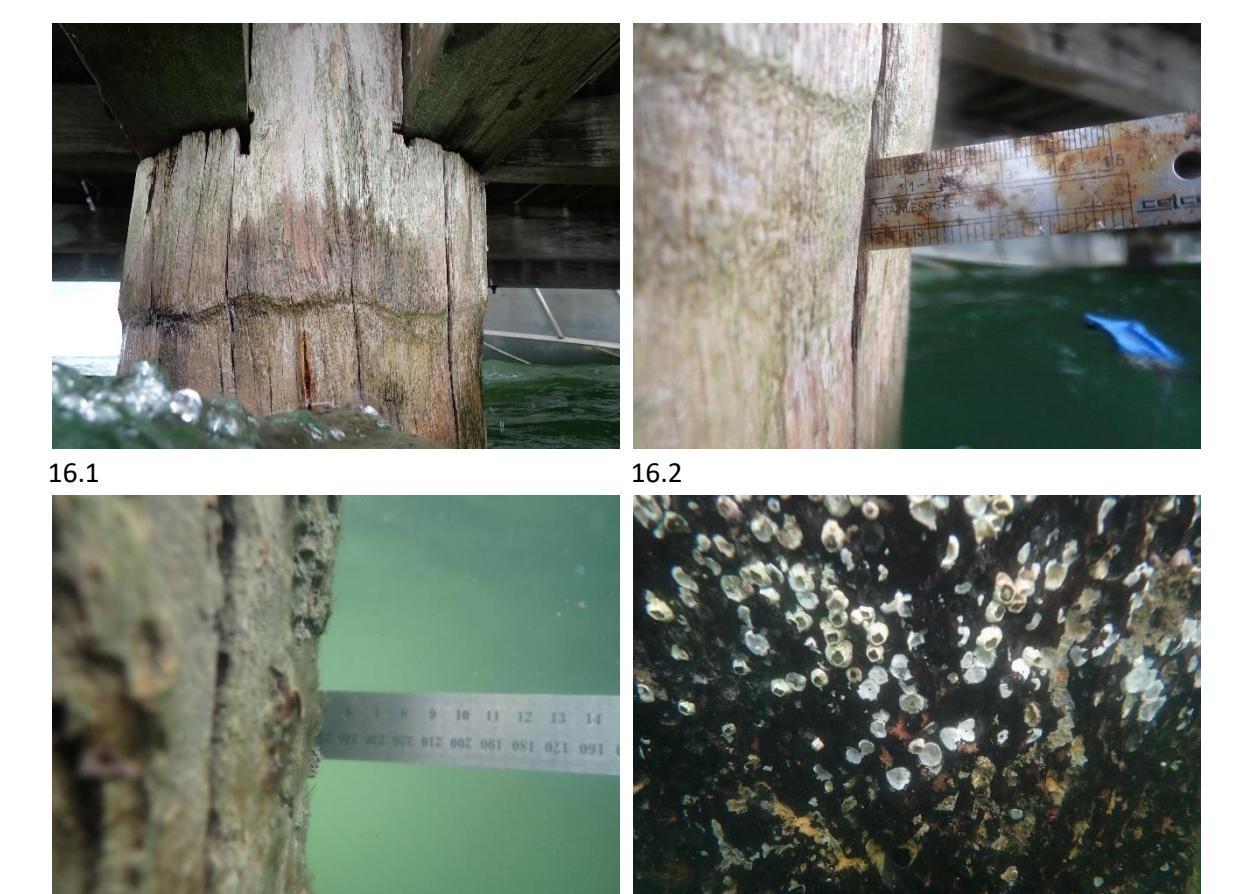
5.16 SITE PHOTOS PILE 8B

- 16.1 Above water section of pile presenting in fair condition, with minor-moderate splitting
- 16.2 example of severe split in pile
- 16.3 Moderate timber rot and marine borer attack throughout intertidal area
- 16.4 Encapsulation formwork presenting in fair condition

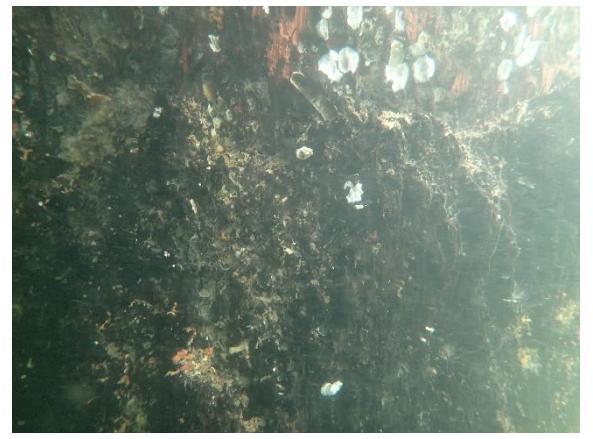
- 20.1, 20.2 & 20.3 Example of large split in pile
- 20.4 Moderate necking at I/T
- 20.5 Example of Wood rot & borer on exposed section of timber pile

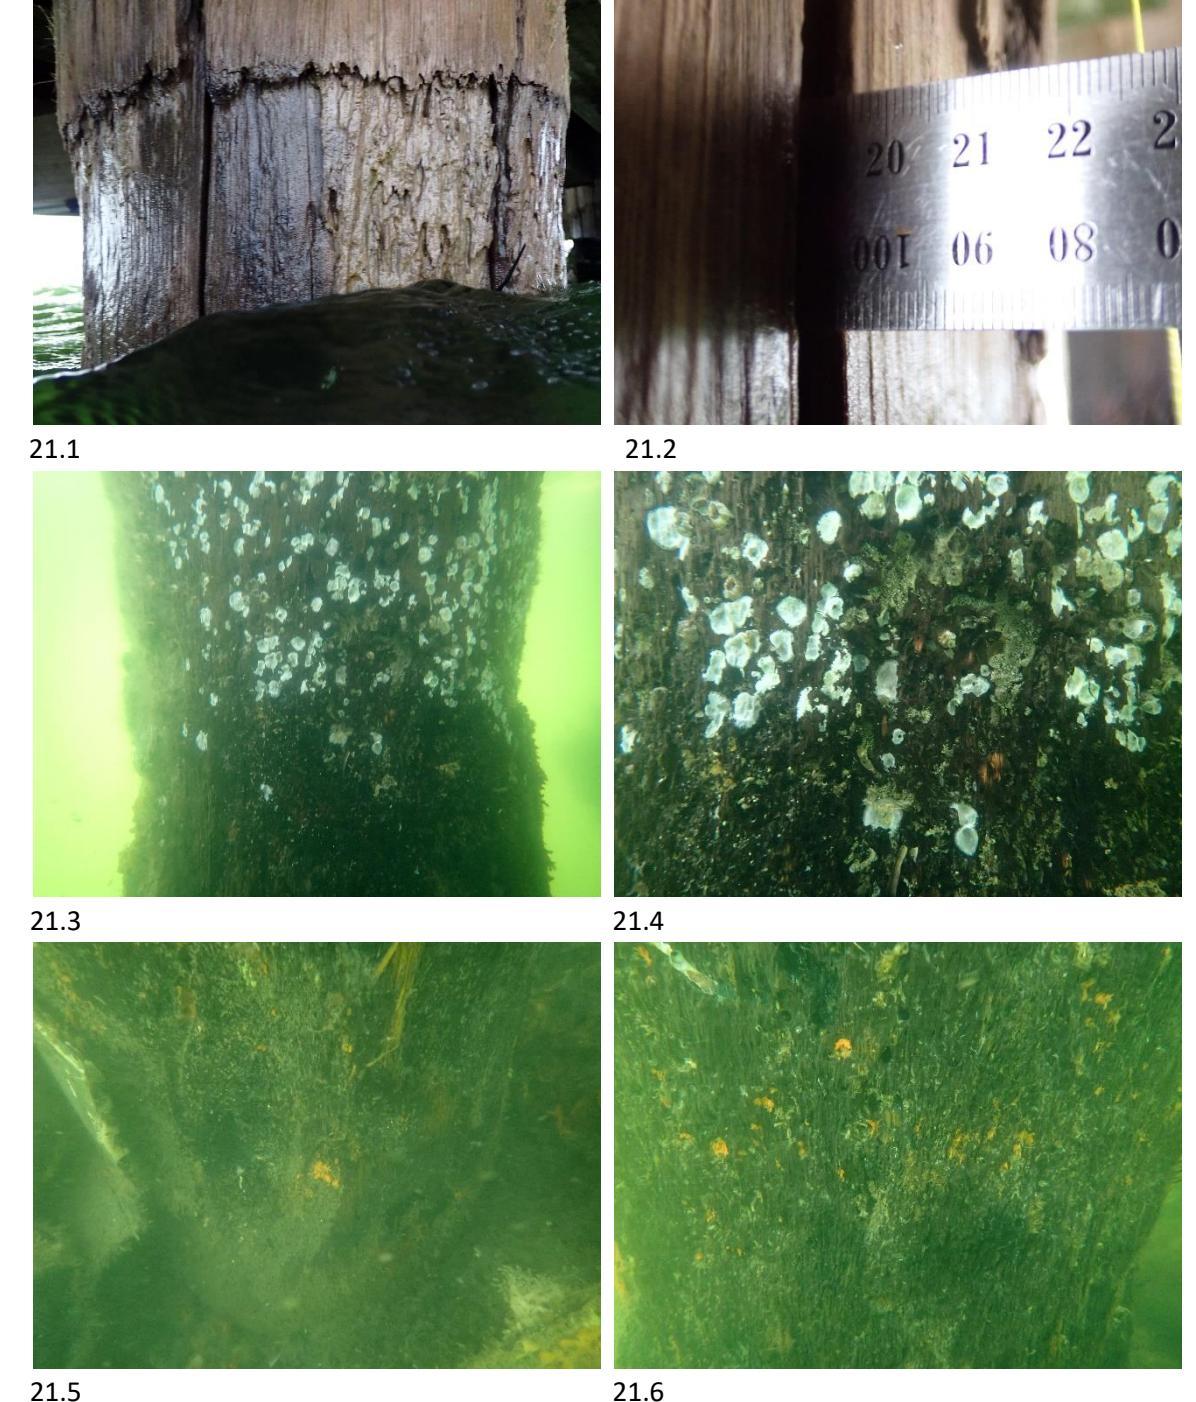
### 5.21 SITE PHOTOS PILE 11A

21.1 & 21.2- Example of large splits in pile

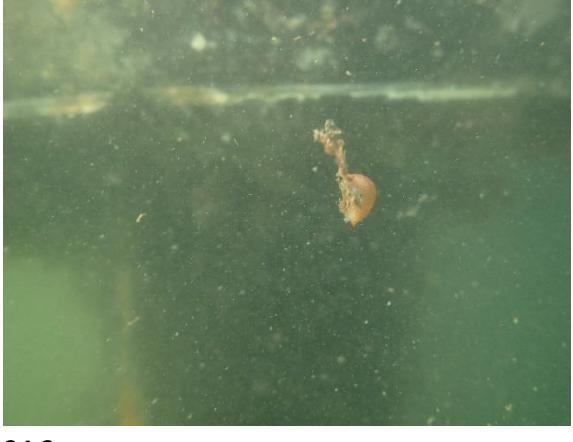
24.1 – Encapsulation extends to midwater and then has completely failed down to seabed. Section loss 240mm x 300mm at top of pile

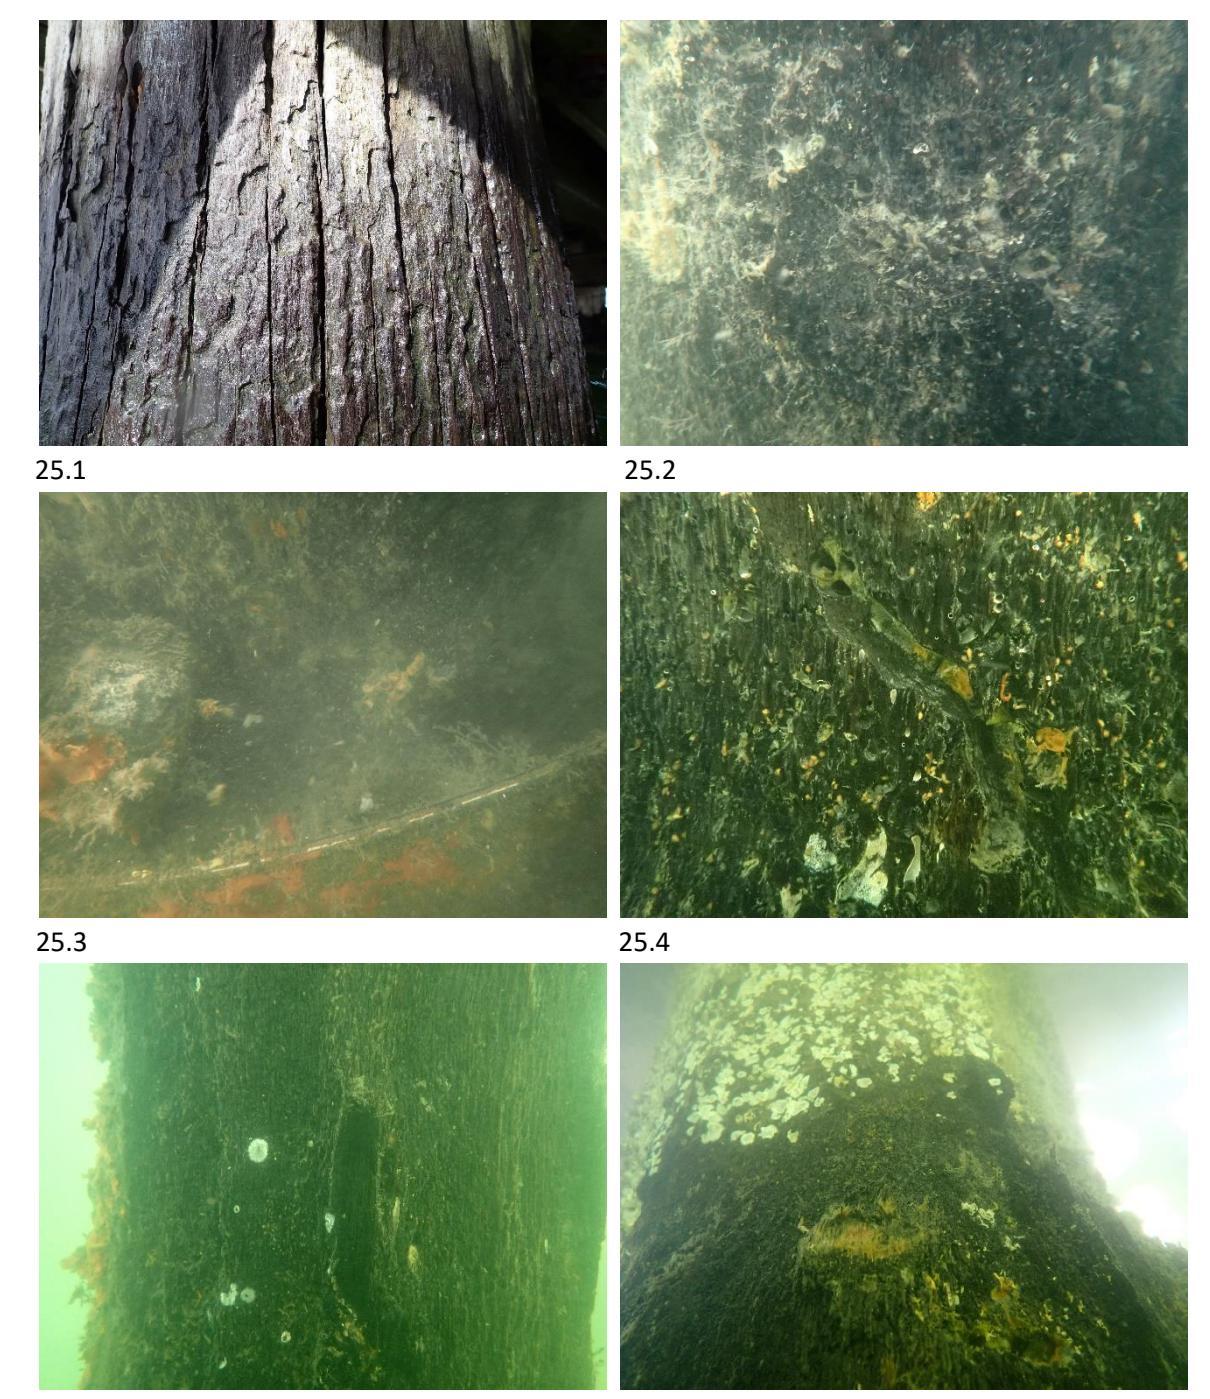
### 5.25 SITE PHOTOS PILE 13A

- 25.1 Above water section of pile, presenting with minor splitting
- 25.2 Example of timber rot and marine borer attack
- 25.3 Example of concrete column finishing below required level
- 25.4 Example of section loss on timber pile
- 25.5 Example of section loss on timber pile
- 25.6 Example of encapsulation failure subsea exposing timber pile

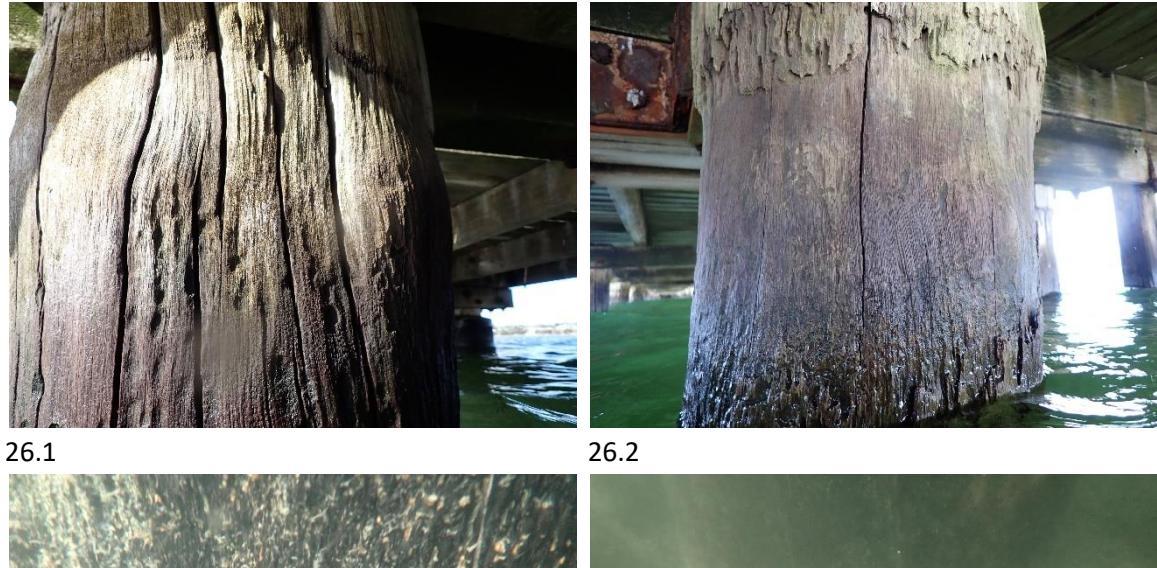
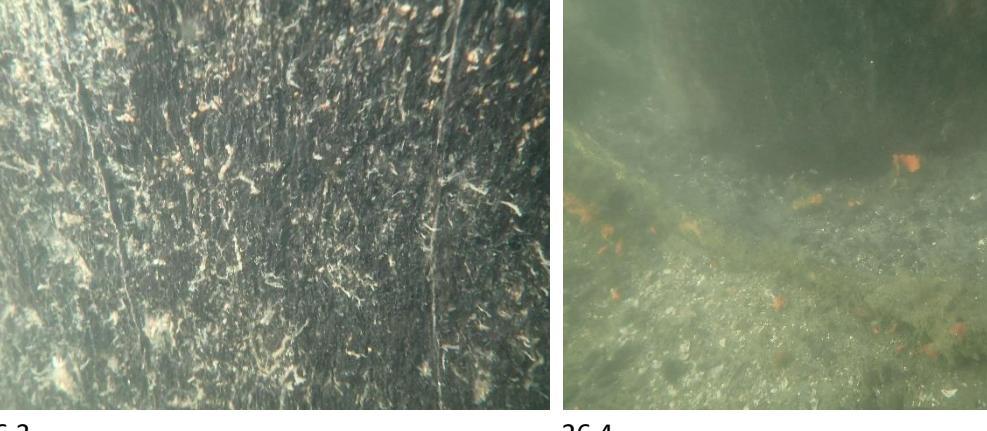
### 5.26 SITE PHOTOS PILE 13B

- 26.1 Example of minor-moderate splitting on above water section of pile
- 26.2 Example of necking present throughout timber pile
- 26.3 Example of timber rot on subsea section of pile
- 26.4 Encapsulation failure around seabed level

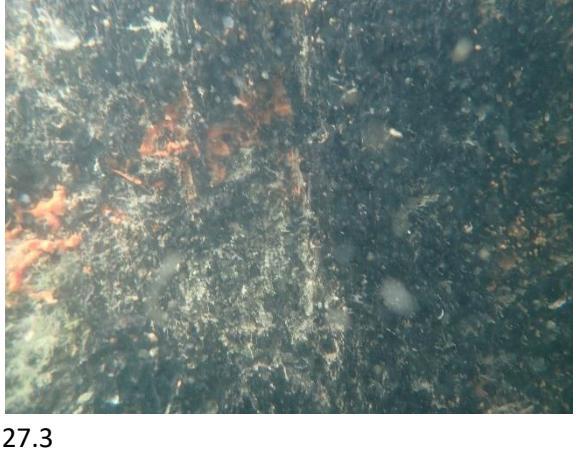
## 5.27 SITE PHOTOS PILE 14A

- 27.1 Example of minor-moderate splitting on above water section of pile
- 27.2 Example of timber rot and borer on subsea section of pile
- 27.3 Example of timber rot and borer on subsea section of pile
- 27.4 Example of timber rot and borer on subsea section of pile

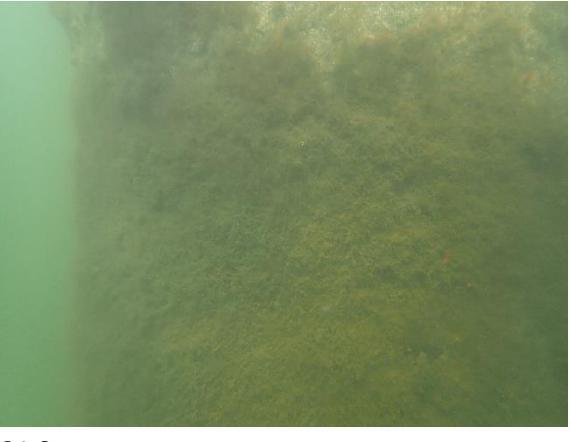
- **31.1** Minor necking above encapsulation.
- 31.2 Encapsulation extends below seabed. Wrap appears in good condition
- 31.3 Encapsulation extends below. Wrap appears in good condition

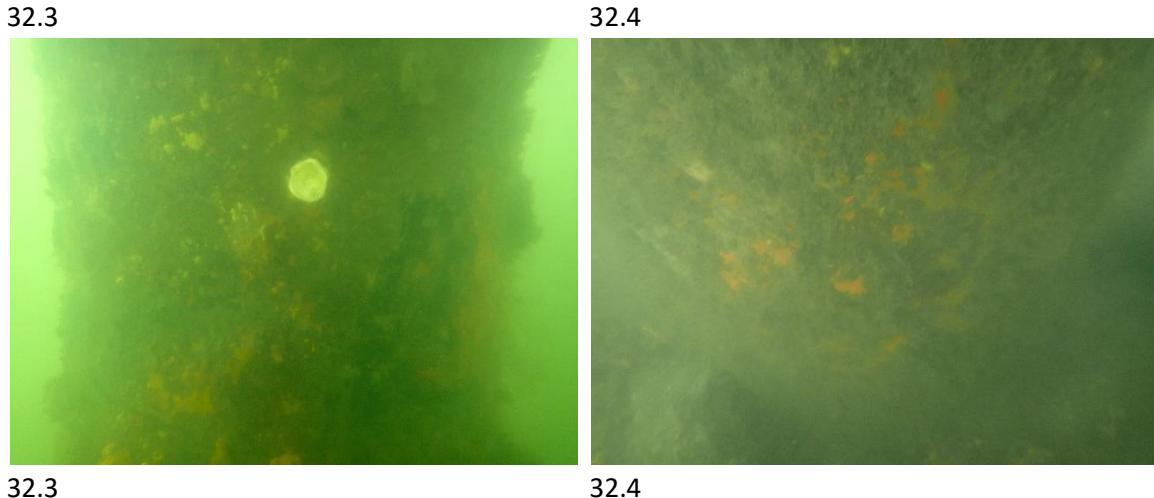
32.1 – Moderate necking above encapsulation visible on one side of the pile with moderate encapsulation section loss

- 32.2 Moderate necking above encapsulation visible
- 32.3 Encapsulation extends below seabed and is completely intact. Wrap appears in good condition
- 32.4 Encapsulation extends below seabed and is completely intact. Wrap appears in good condition

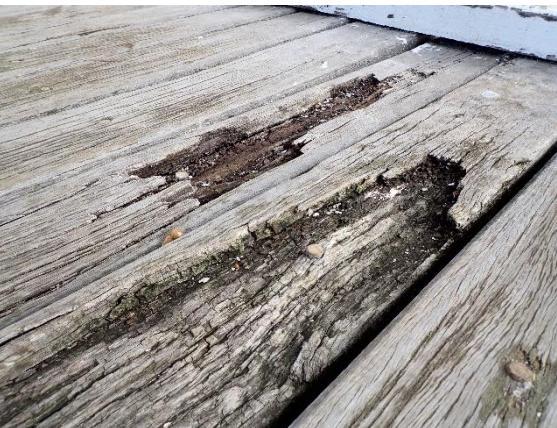
Timber decking, kerbing and handrail generally presented in average condition. Deck boards presented with minor to moderate surface splitting throughout, with 25% exhibiting severe rot. Similar defects were present on the kerbing, with rot typically localised to the ends of each member. Two lengths of timber handrail were missing from the "midrail" level of this element.

- 33.1 Missing sections of handrail
- 33.2 Section loss and localised rot on deck boards
- 33.3 Example of wood rot on timber kerbing
- 33.4 Section loss on walkway timber
- 33.5 Section loss on walkway timber
- 33.6 Section loss on walkway timber
