9738

Australind Jetty

# **Australind Jetty Inspection Findings**

# **JETTY INSPECTION & REPORT**

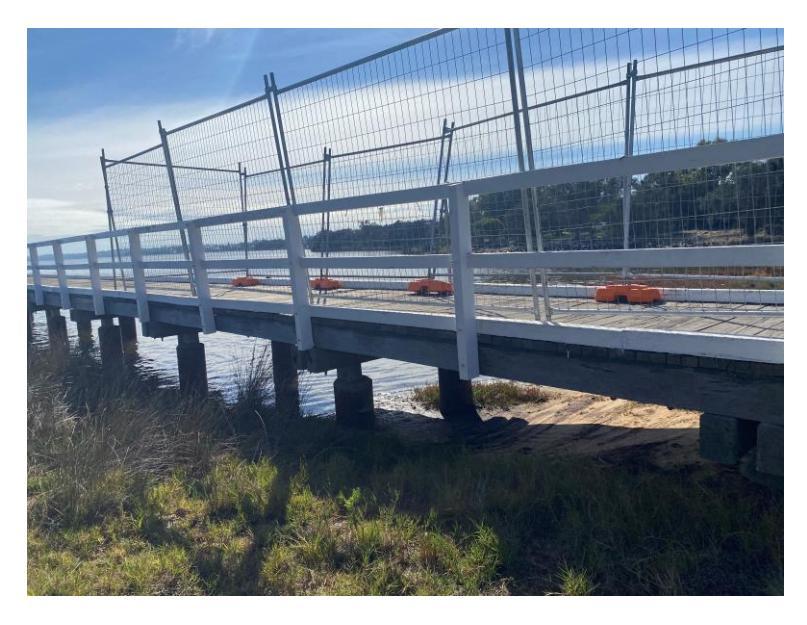
Figure 1. General at the Shore

It has approximately 60 circular concrete piles encased with a wrapping or liner, with timber stumps, half-caps and joists spanning between them (Figure 1). The timber joists are located at approximately third points across the width of the walkway. These half-caps are fixed to the timber stumps via two bolts. Also, the joists are bolted to the half-caps (Figure 7). Supported on these timber joists are the deck boards, which have a toe board bolted around the edge.

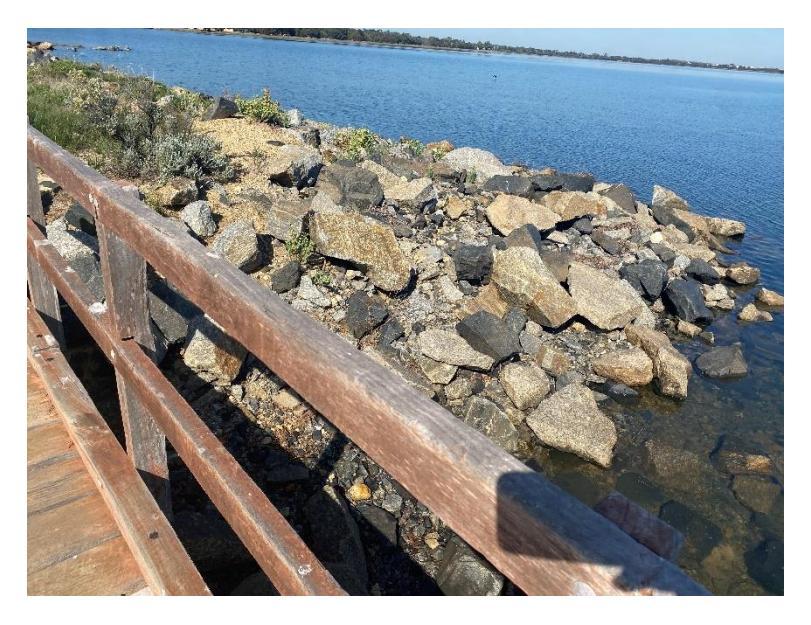
Figure 9. Weathered Handrail

Generally, all the deck boards, and toe boards appear to be okay, but a bit weathered. Several deck boards have cupped or split and there is the occasional loose one (Figure 9). However, these are not considered to be affecting the structural performance.

Due to the extent of deterioration to the deck boards. We recommend that they all be replaced. It would be prudent, with the boards removed, to inspect and replace the protective barrier over the joists.

We recommend the handrail arrangement is reviewed by yourselves, with regard to the extent and type of barrier.

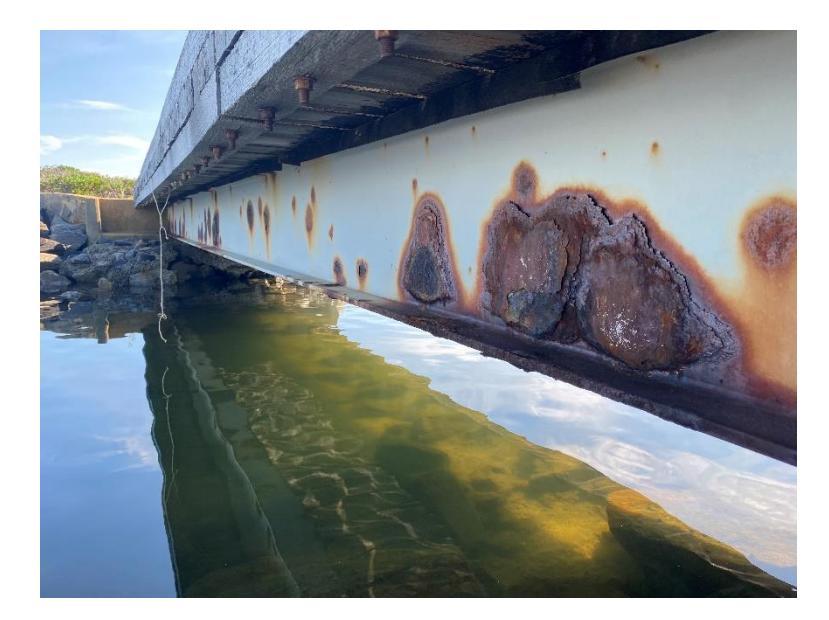
Figure 18. Delaminated Steel Beam

Most of the steelwork is showing signs of corrosion. All the bolts and the steel beams observed are rusted and, in several areas, delaminated (Figure 16, Figure 17, Figure 18).

All bolts should be replaced. We recommend that all the new bolts be stainless steel. Otherwise, galvanised bolts are acceptable, subject to a regular inspection regime.

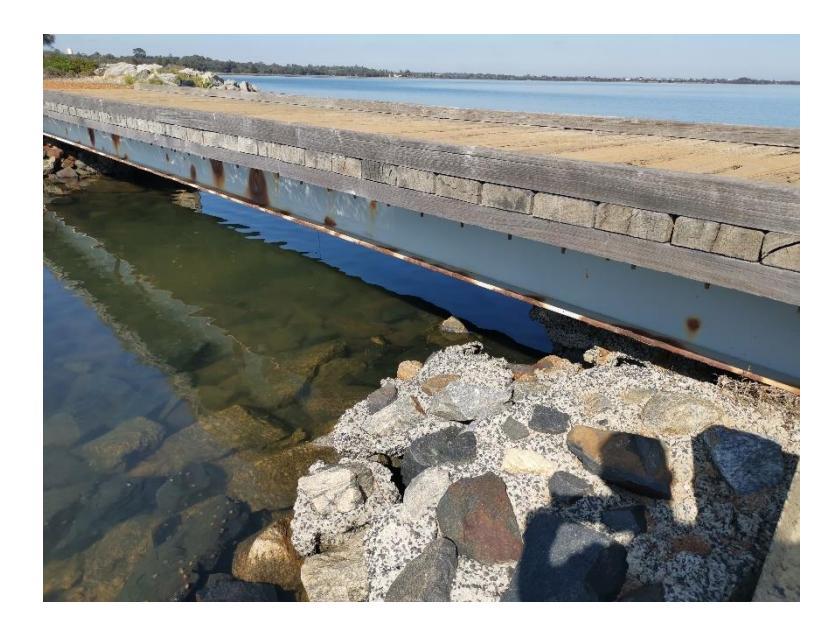
Figure 19. Deck Board

Generally, all the timber deck boards, and toe boards appear to be okay, if a bit weathered. Several deck boards have cupped or split and there is the occasional loose one (Figure 19). However, these are not considered to be affecting the structural performance.

Due to the extent of deterioration to the deck boards. We recommend that they all be replaced. It would be prudent, with the boards removed, to inspect and replace the protective barrier over the joists.

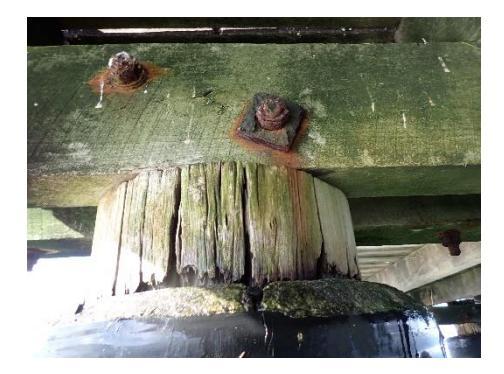
Image 2. Example of Typical Halfcap Connection at each pile

Piles within each bent share two timber halfcaps that are fastened with a through-bolts on a notch out grove on the tops of each pile, as shown in image 1, below.

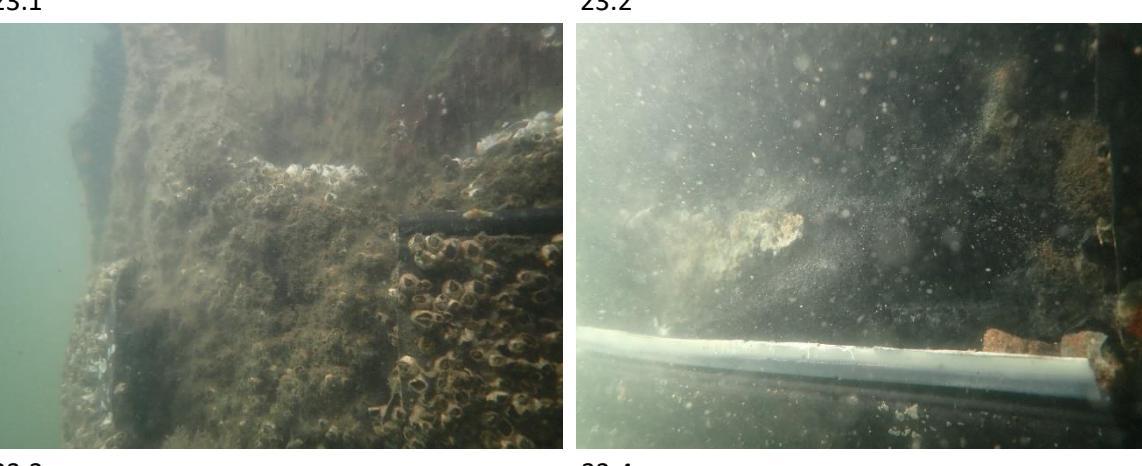
- 23.1 Encapsulation extends below seabed. Section loss 500mm x 600mm at top of pile.
- 23.2 Encapsulation extends below seabed. Section loss 500mm x 600mm at top of pile.
- 23.3 Section loss midwater 220mm x 240mm
- 23.4 Section loss midwater 220mm x 240mm

The majority of existing timber encapsulations have failed entirely and are providing no benefit to the structure. In addition to this, the timber piles have deteriorated past the point wherein a preventative timber protection system would be suitable, such as the Denso Seasheild 80 series system. Instead, it is anticipated that a structural repair is required.

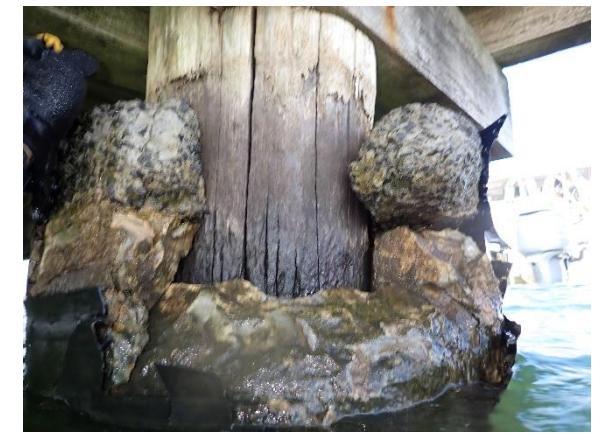
24.1 – Encapsulation extends to midwater and then has completely failed down to seabed. Section loss 240mm x 300mm at top of pile

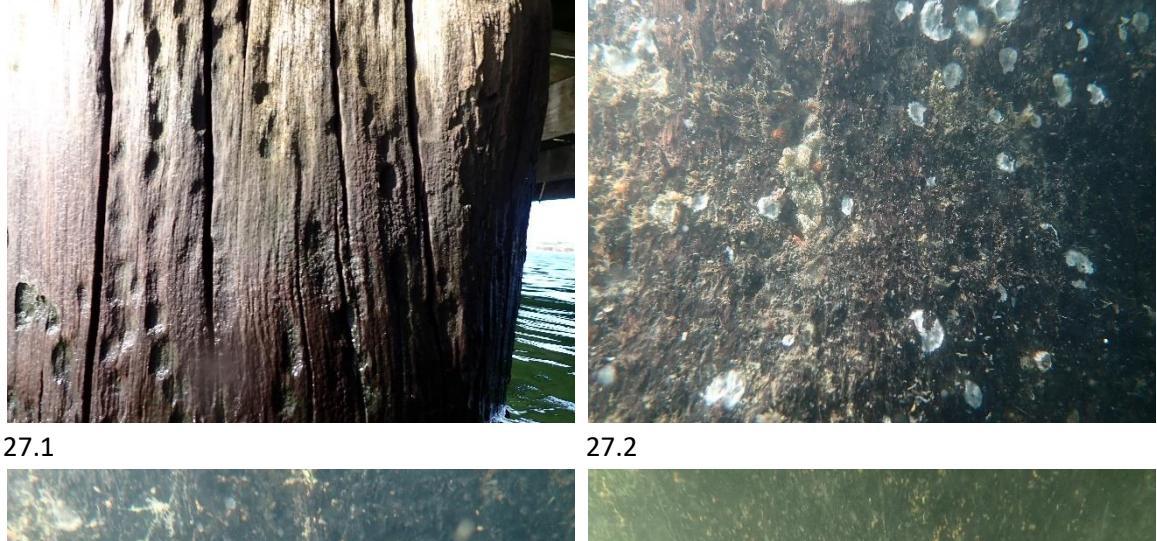
- 27.1 Example of minor-moderate splitting on above water section of pile
- 27.2 Example of timber rot and borer on subsea section of pile
- 27.3 Example of timber rot and borer on subsea section of pile
- 27.4 Example of timber rot and borer on subsea section of pile

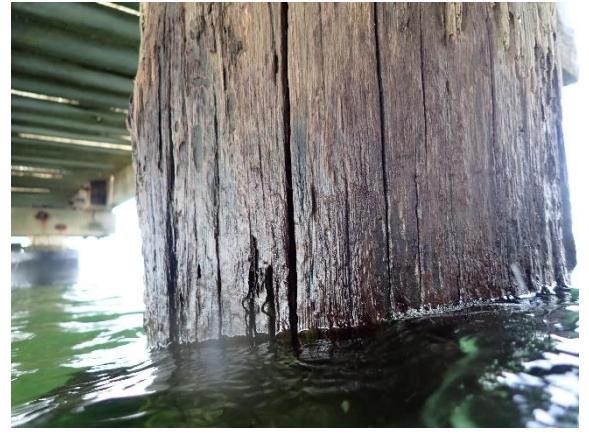
- 28.1 Example of minor-moderate splitting on above water section of pile
- 28.2 Example of minor-moderate splitting on above water section of pile
- 28.3 Example of severe timber rot and borer on subsea section of pile 28.4 Wood rot & borer
- 28.5 Example of severe timber rot and borer on subsea section of pile
- 28.6 Encapsulation has completely failed to seabed level

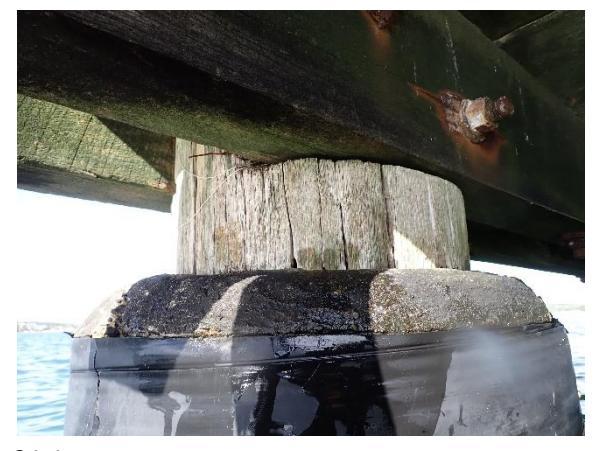
31.1

- **31.1** Minor necking above encapsulation.
- 31.2 Encapsulation extends below seabed. Wrap appears in good condition
- 31.3 Encapsulation extends below. Wrap appears in good condition

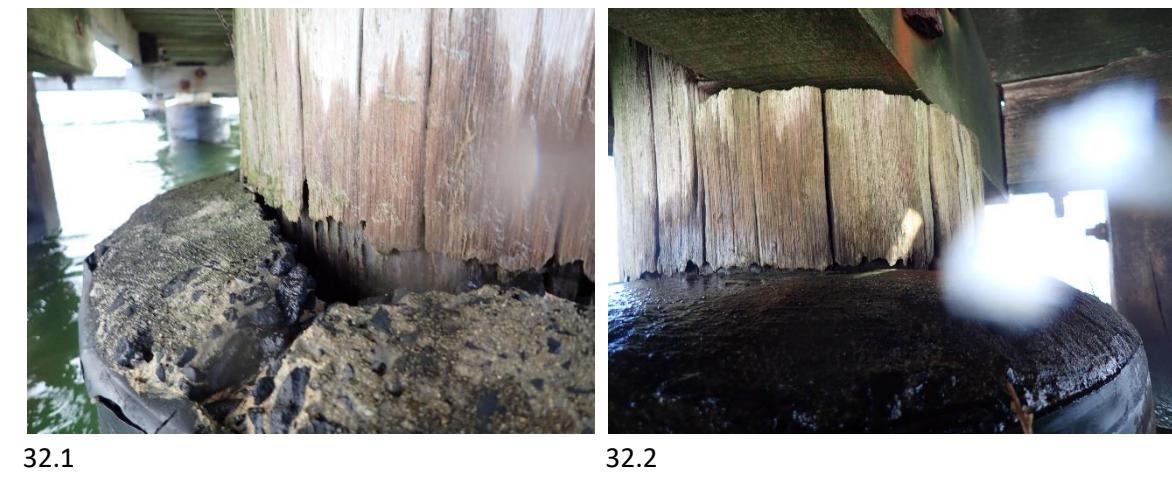
32.1 – Moderate necking above encapsulation visible on one side of the pile with moderate encapsulation section loss

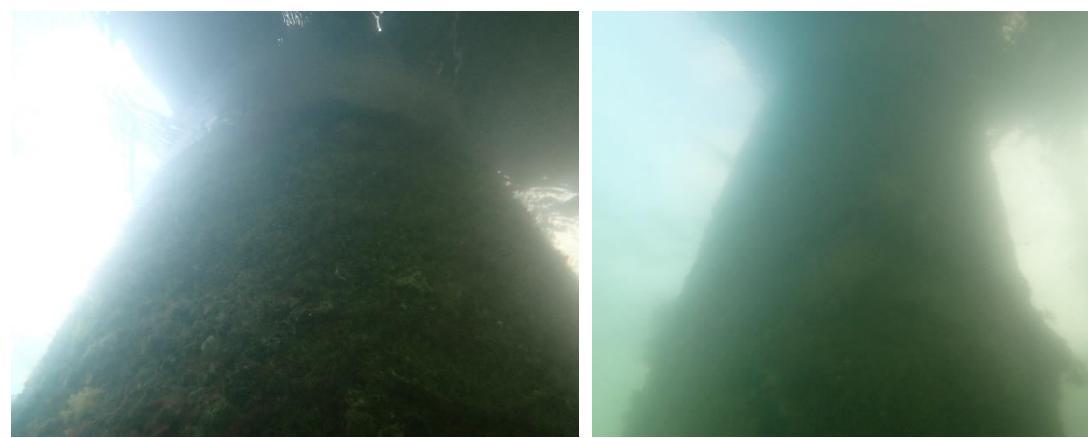
- 32.2 Moderate necking above encapsulation visible
- 32.3 Encapsulation extends below seabed and is completely intact. Wrap appears in good condition
- 32.4 Encapsulation extends below seabed and is completely intact. Wrap appears in good condition

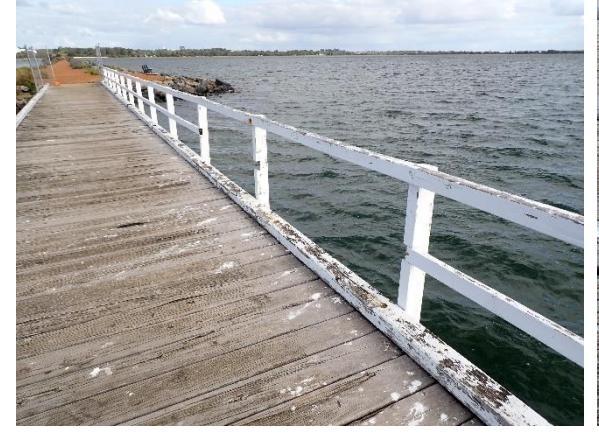
- 33.1 Missing sections of handrail
- 33.2 Section loss and localised rot on deck boards
- 33.3 Example of wood rot on timber kerbing
- 33.4 Section loss on walkway timber
- 33.5 Section loss on walkway timber
- 33.6 Section loss on walkway timber

- Near complete failure of the existing concrete pile encapsulations
- Generally poor condition of exposed sections of timber piles
- Moderate to severe corrosion present on structural fixings
- Deterioration of deck boards and kerbing
- Missing section of the timber handrail
